Issues the Core Team Needs to Address

Raymond C. Vaughan

January 15, 2008

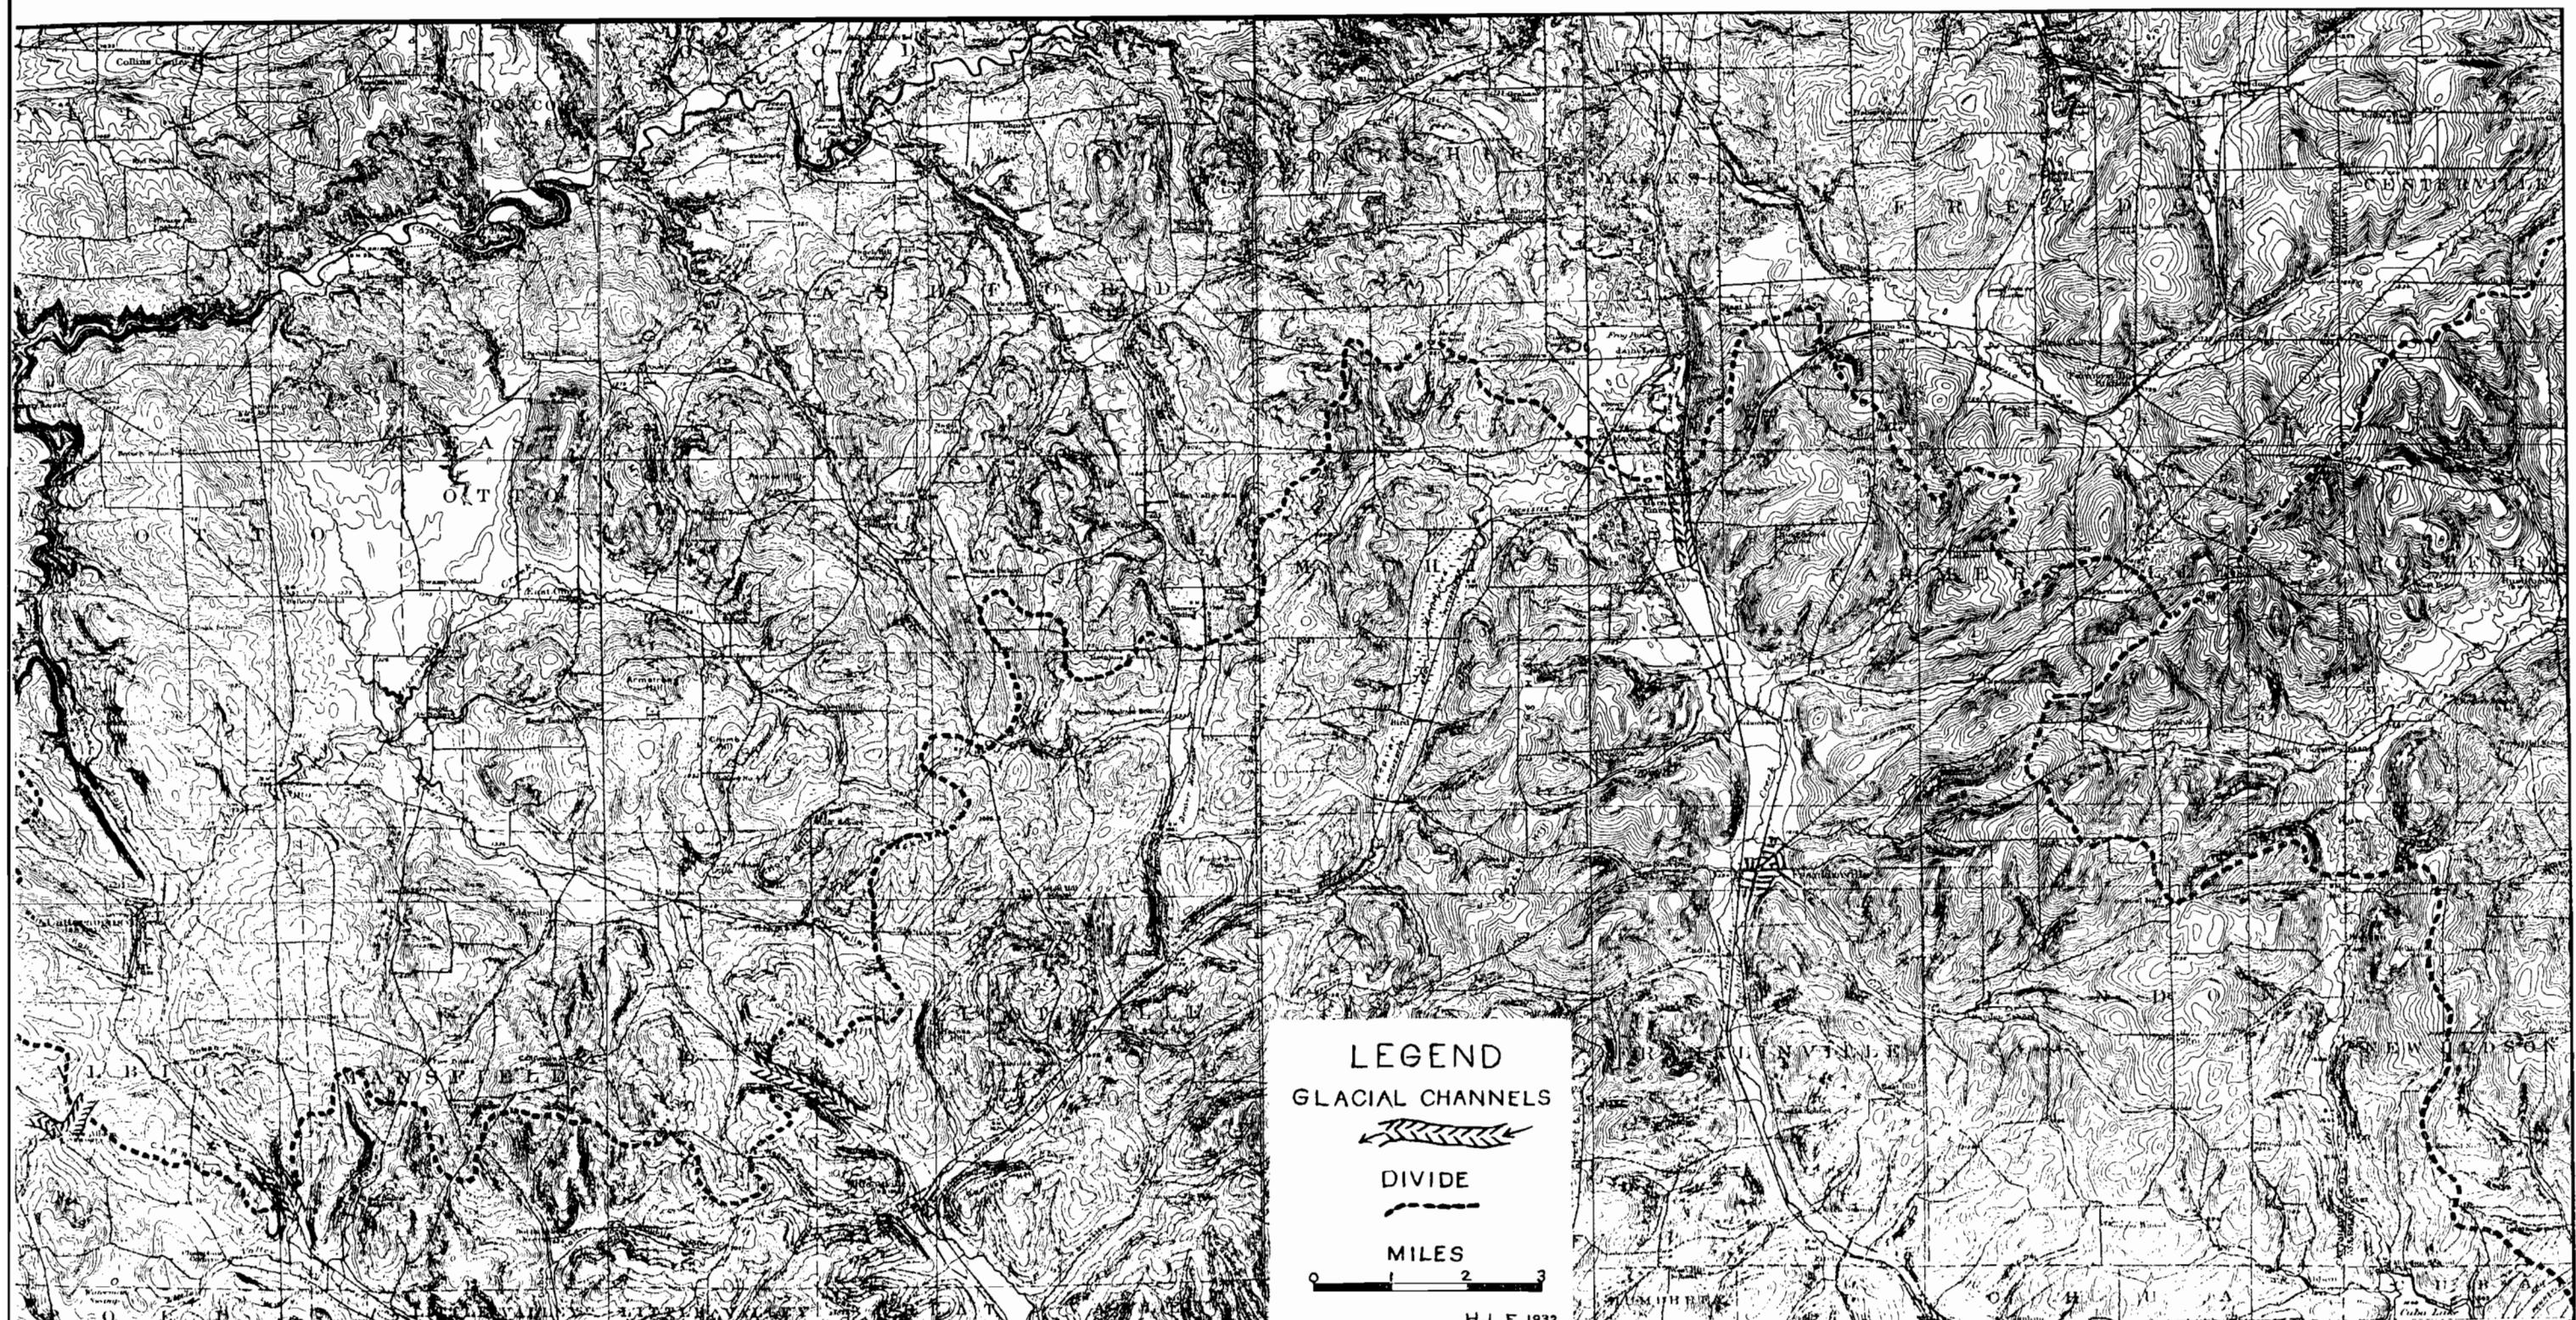
CATTARAUGUS VALLEY GLACIAL WATERS AND THEIR OUTFLOW CHANNELS

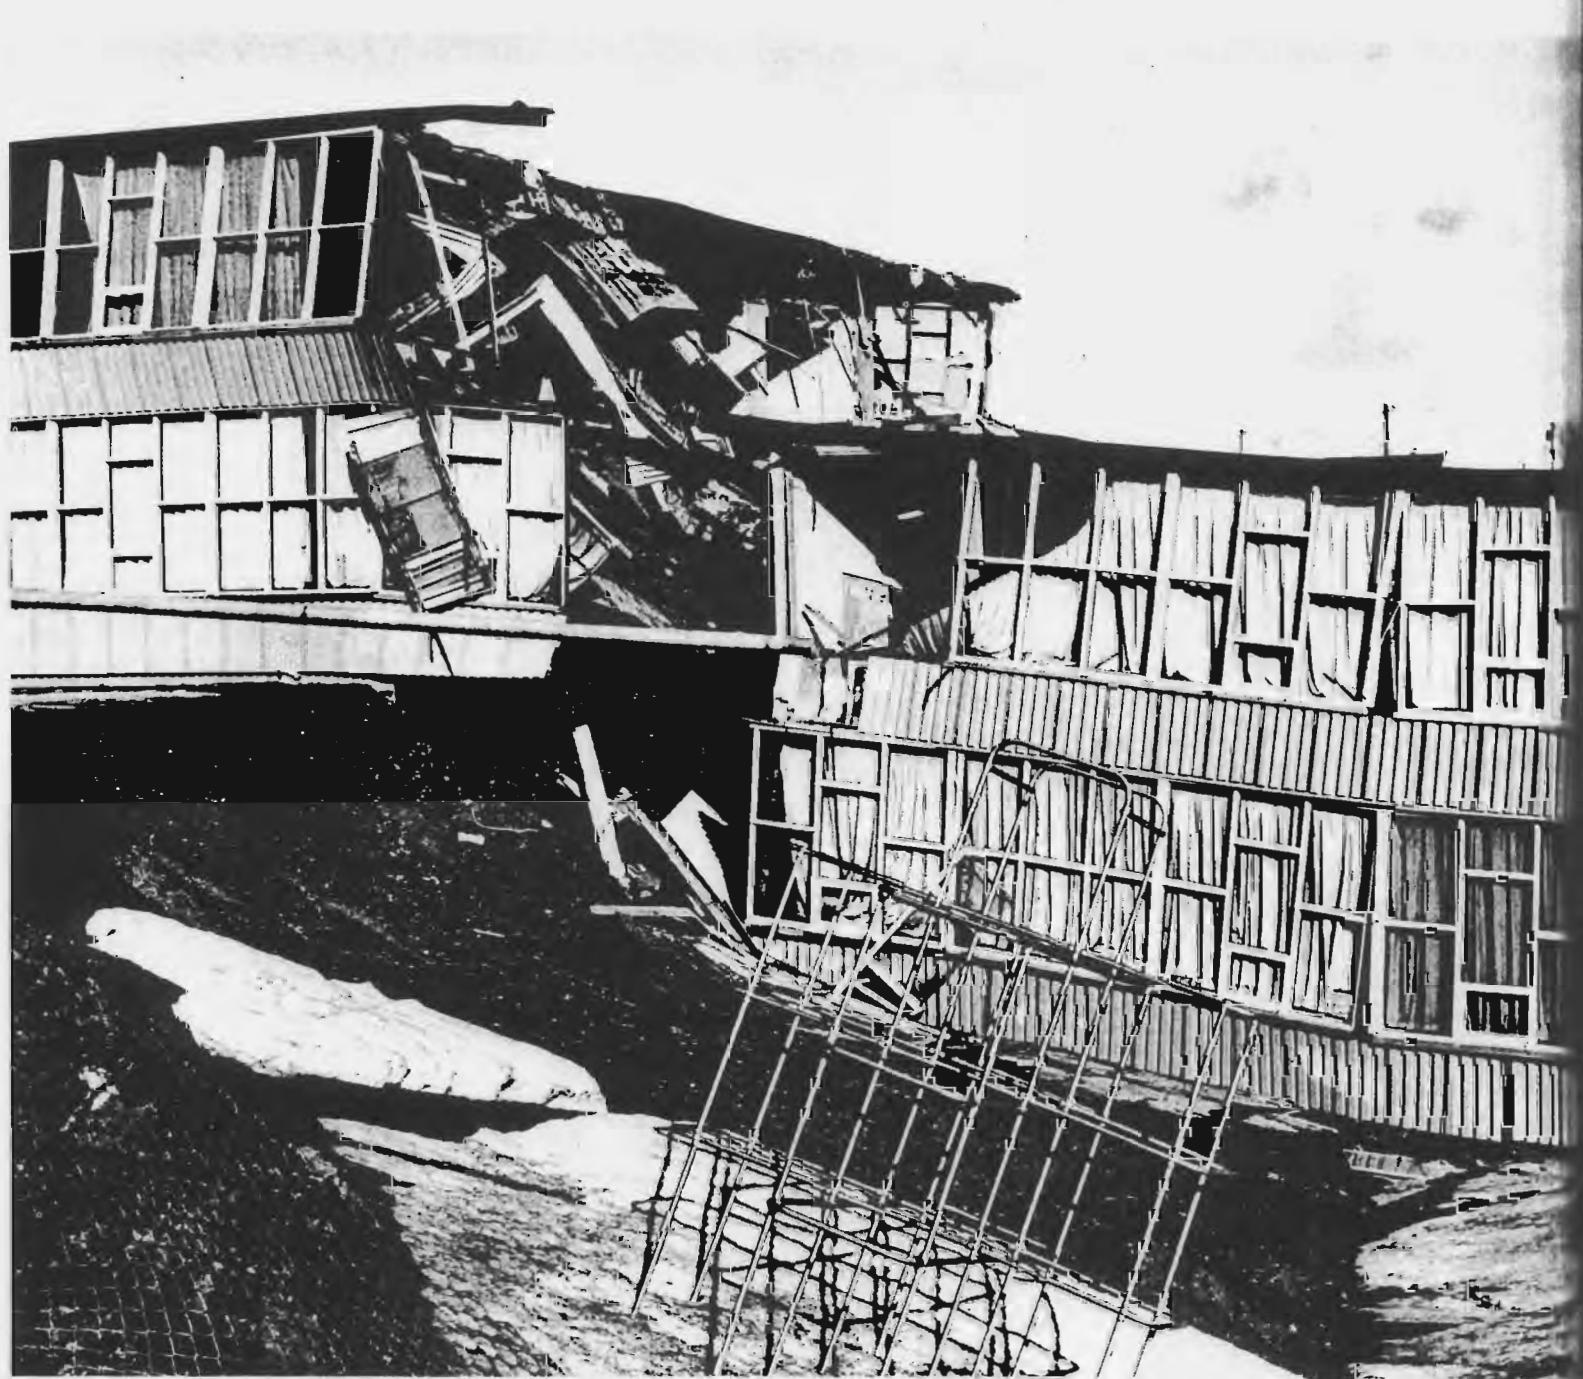
3.—Wreckage of Government Hill School. The south wing of the building, shown here, collapsed into a graben at 11:45 A.M. on April 18, 1906.

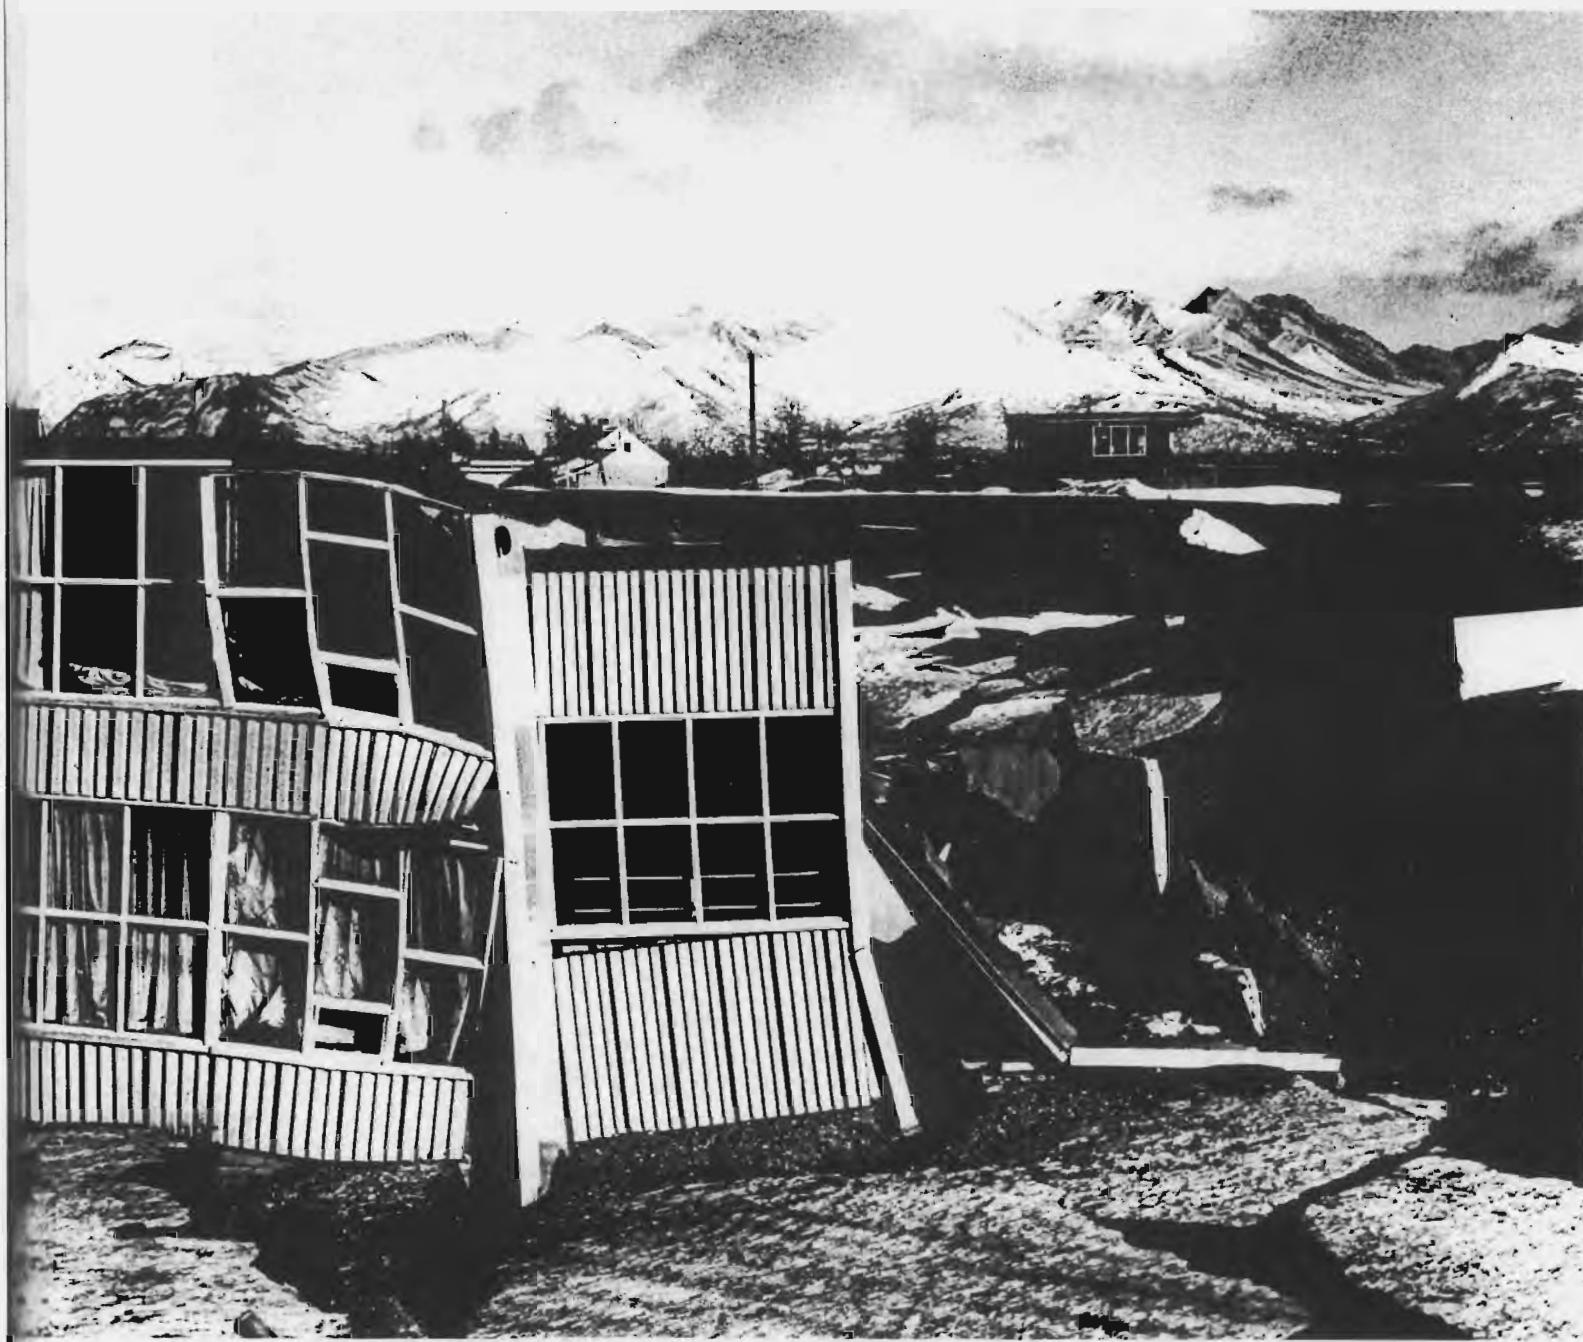
end of the slide. Net slip of the graben block is shown by the displacement of the roofline. Photograph by M. G. Bonilla.

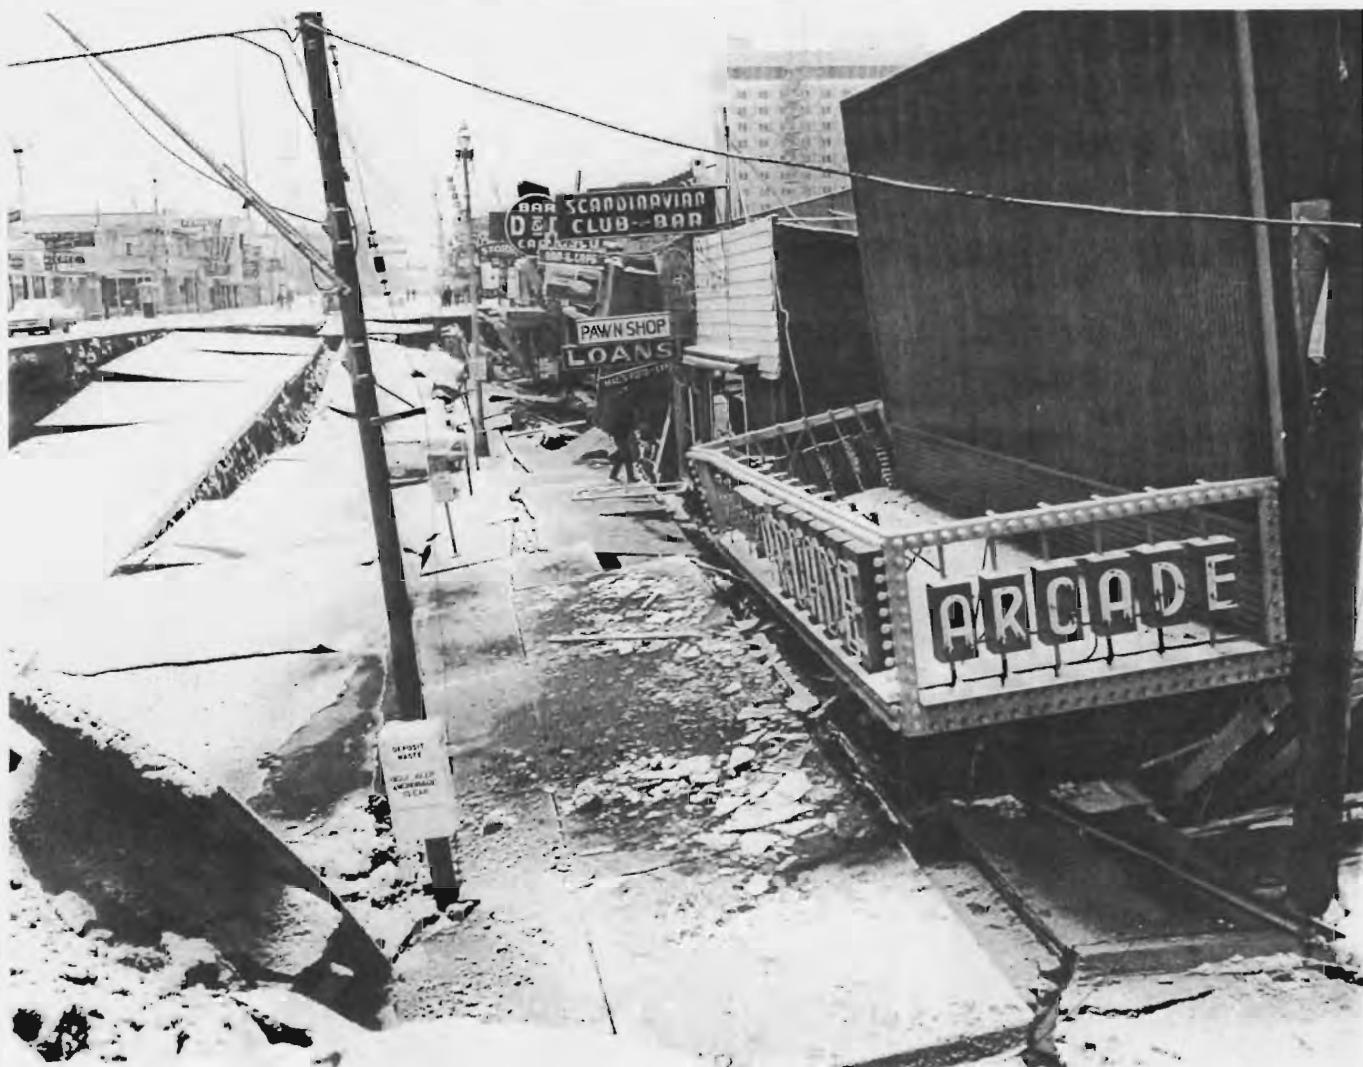
4.—View west along Fourth Avenue at head of landslide. North (right) side of street has collapsed into a graben. Vertical displacement is about 10 feet. Photograph by Mac's Foto, Anchorage, Alaska.

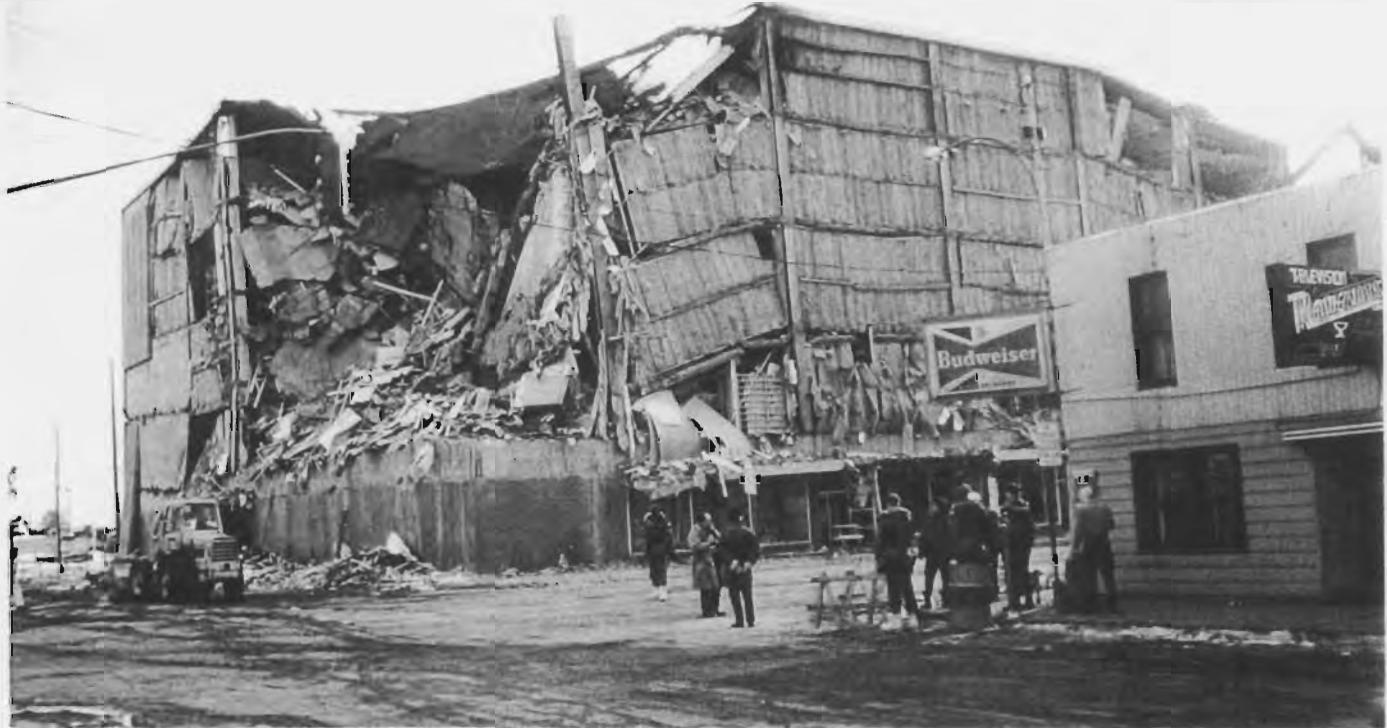
5.—Wreckage of Penney's department store, Fifth Avenue and D Street, Anchorage. Building failed after sustained seismic shaking. Most of rubble has been cleared from streets. Photograph by George Plafker.

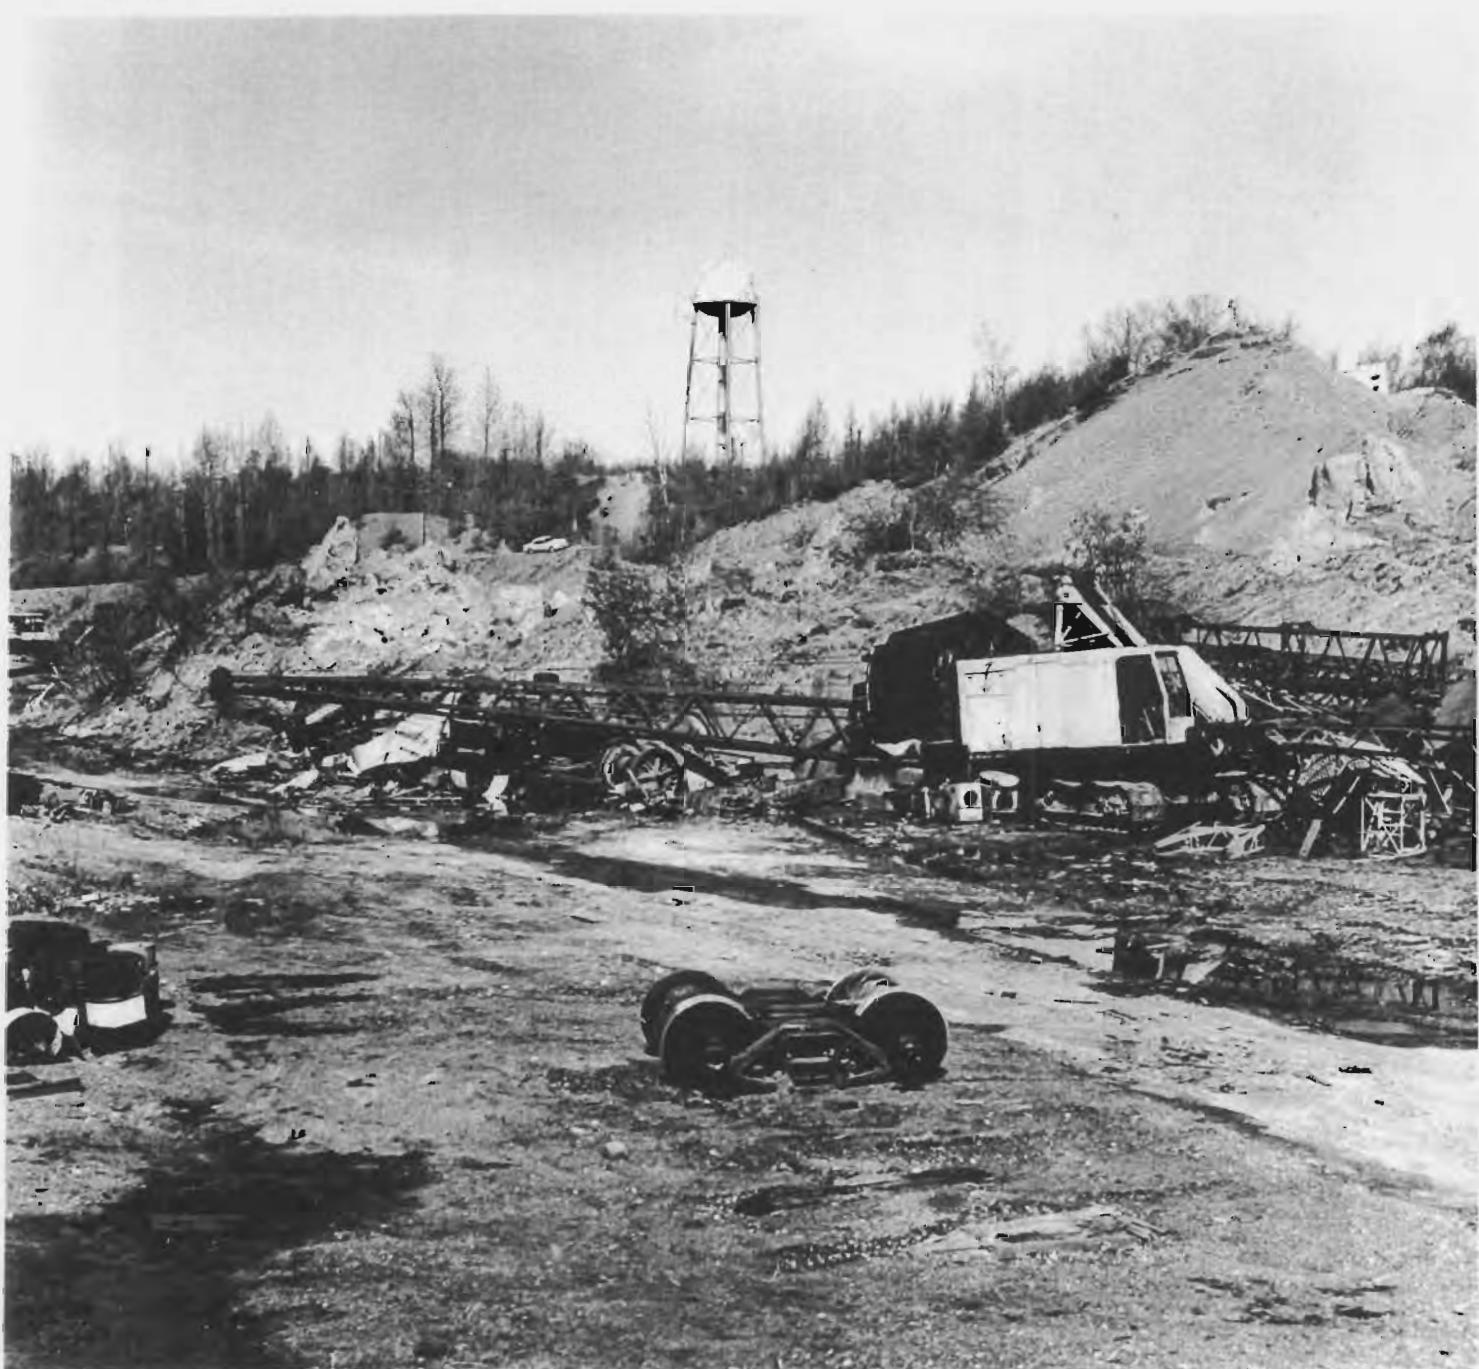
6.—Damage to yards of The Alaska Railroad, looking northwest, caused by earthflow at toe of Government Hill slide. Note undamaged water tank in background.

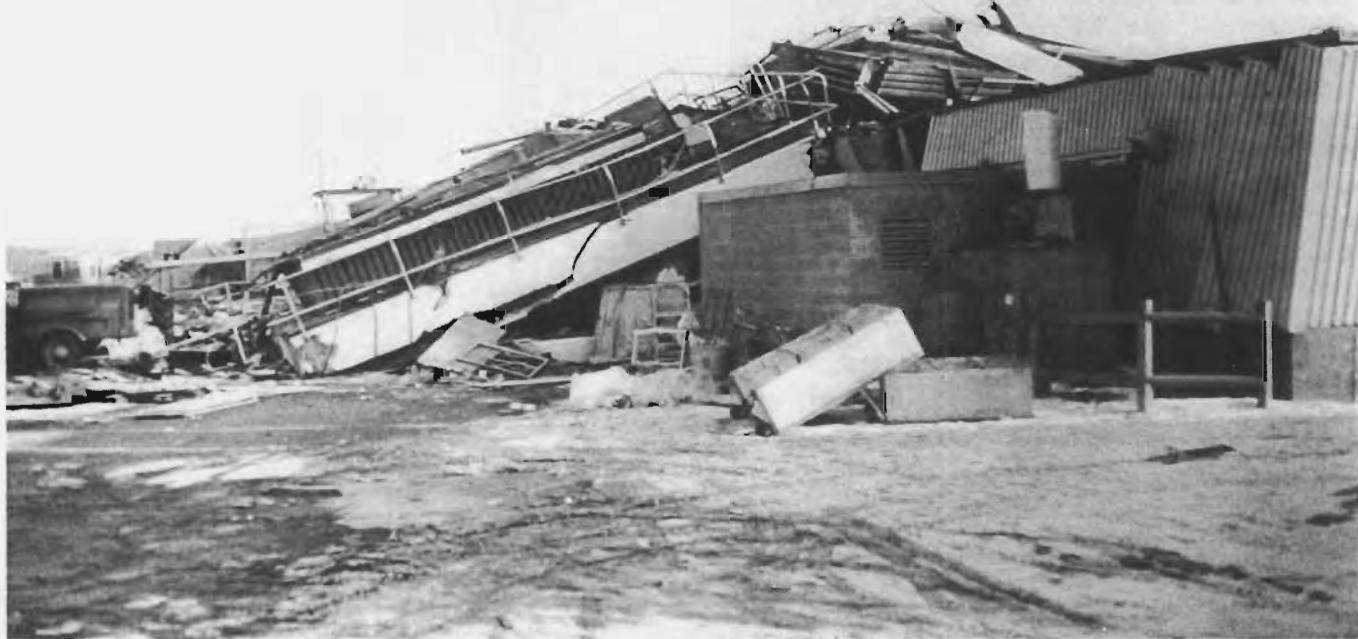
7.—Wreckage of control tower at Anchorage International Airport. Six-story tower failed under sustained seismic shaking.
Photograph by George Plafker.

At the Anchorage International Airport, the control tower failed under seismic vibration and collapsed to the ground (fig. 7), killing one occupant and injuring another. The airport terminal building, although tied structurally to the tower, was only slightly

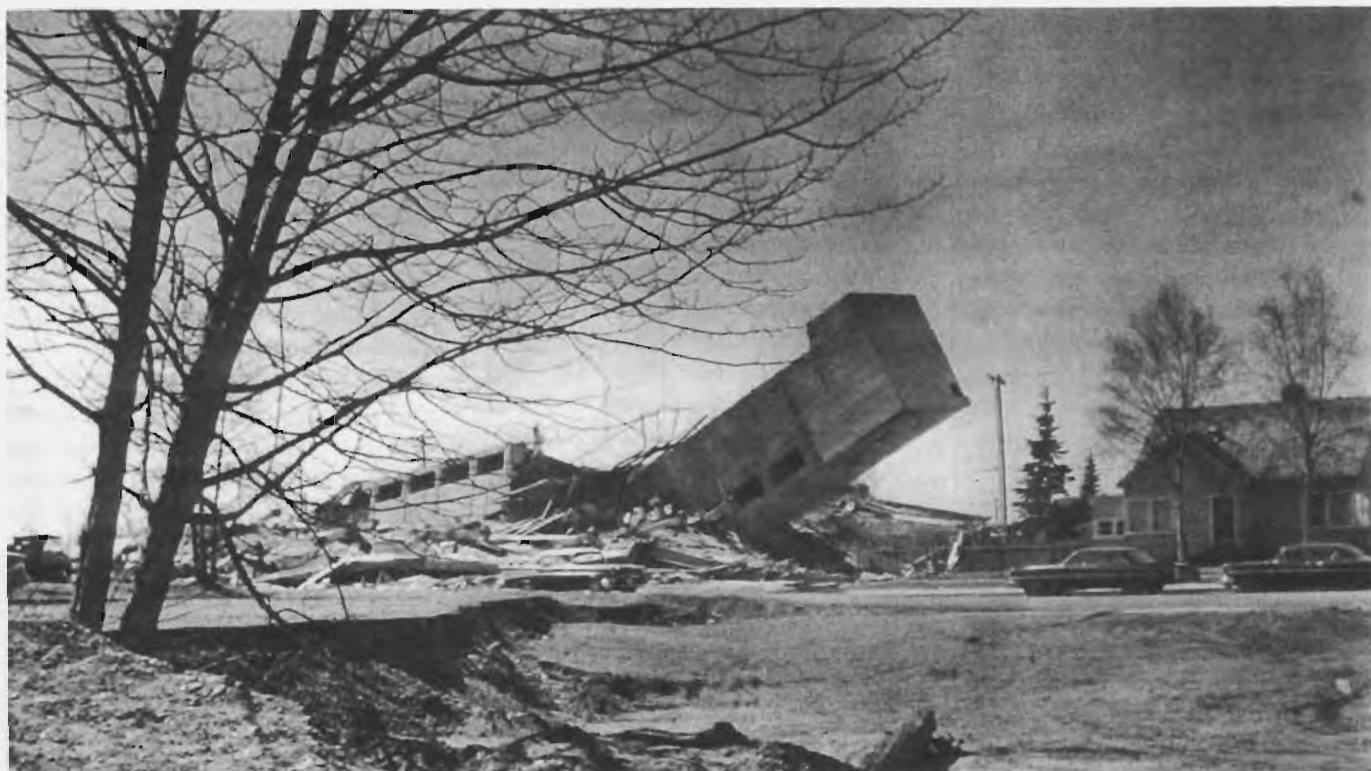
13.—Wreckage of six-story Four Seasons Apartment Building, Anchorage, Alaska. Canted elevator shaft at center. Large crack in foreground, filled in on M Street to restore traffic, passed beneath building.

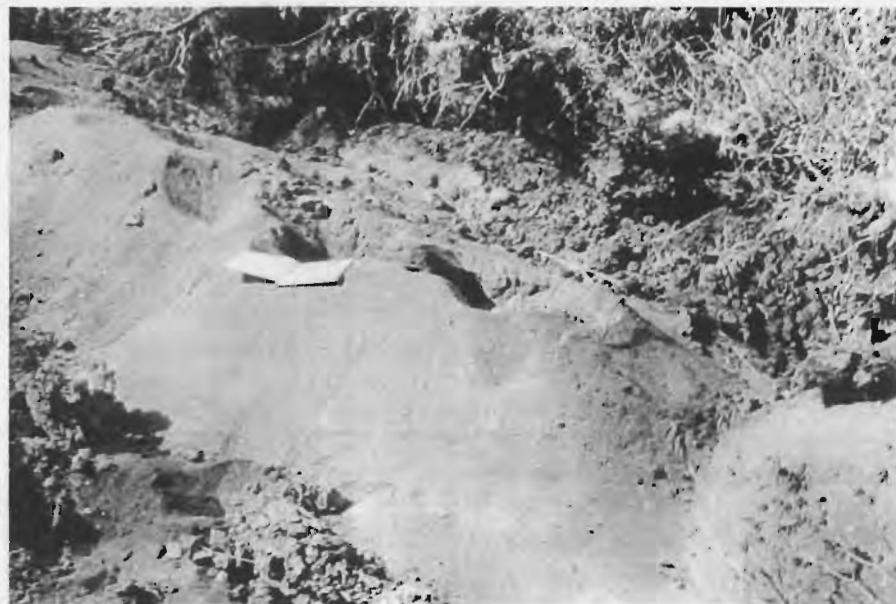
15.—Part of a sand boil, Turnagain Heights slide area. Ridges 2 to 3 feet high and 100 feet long or more were formed as fountains of water were ejected through frozen outwash.

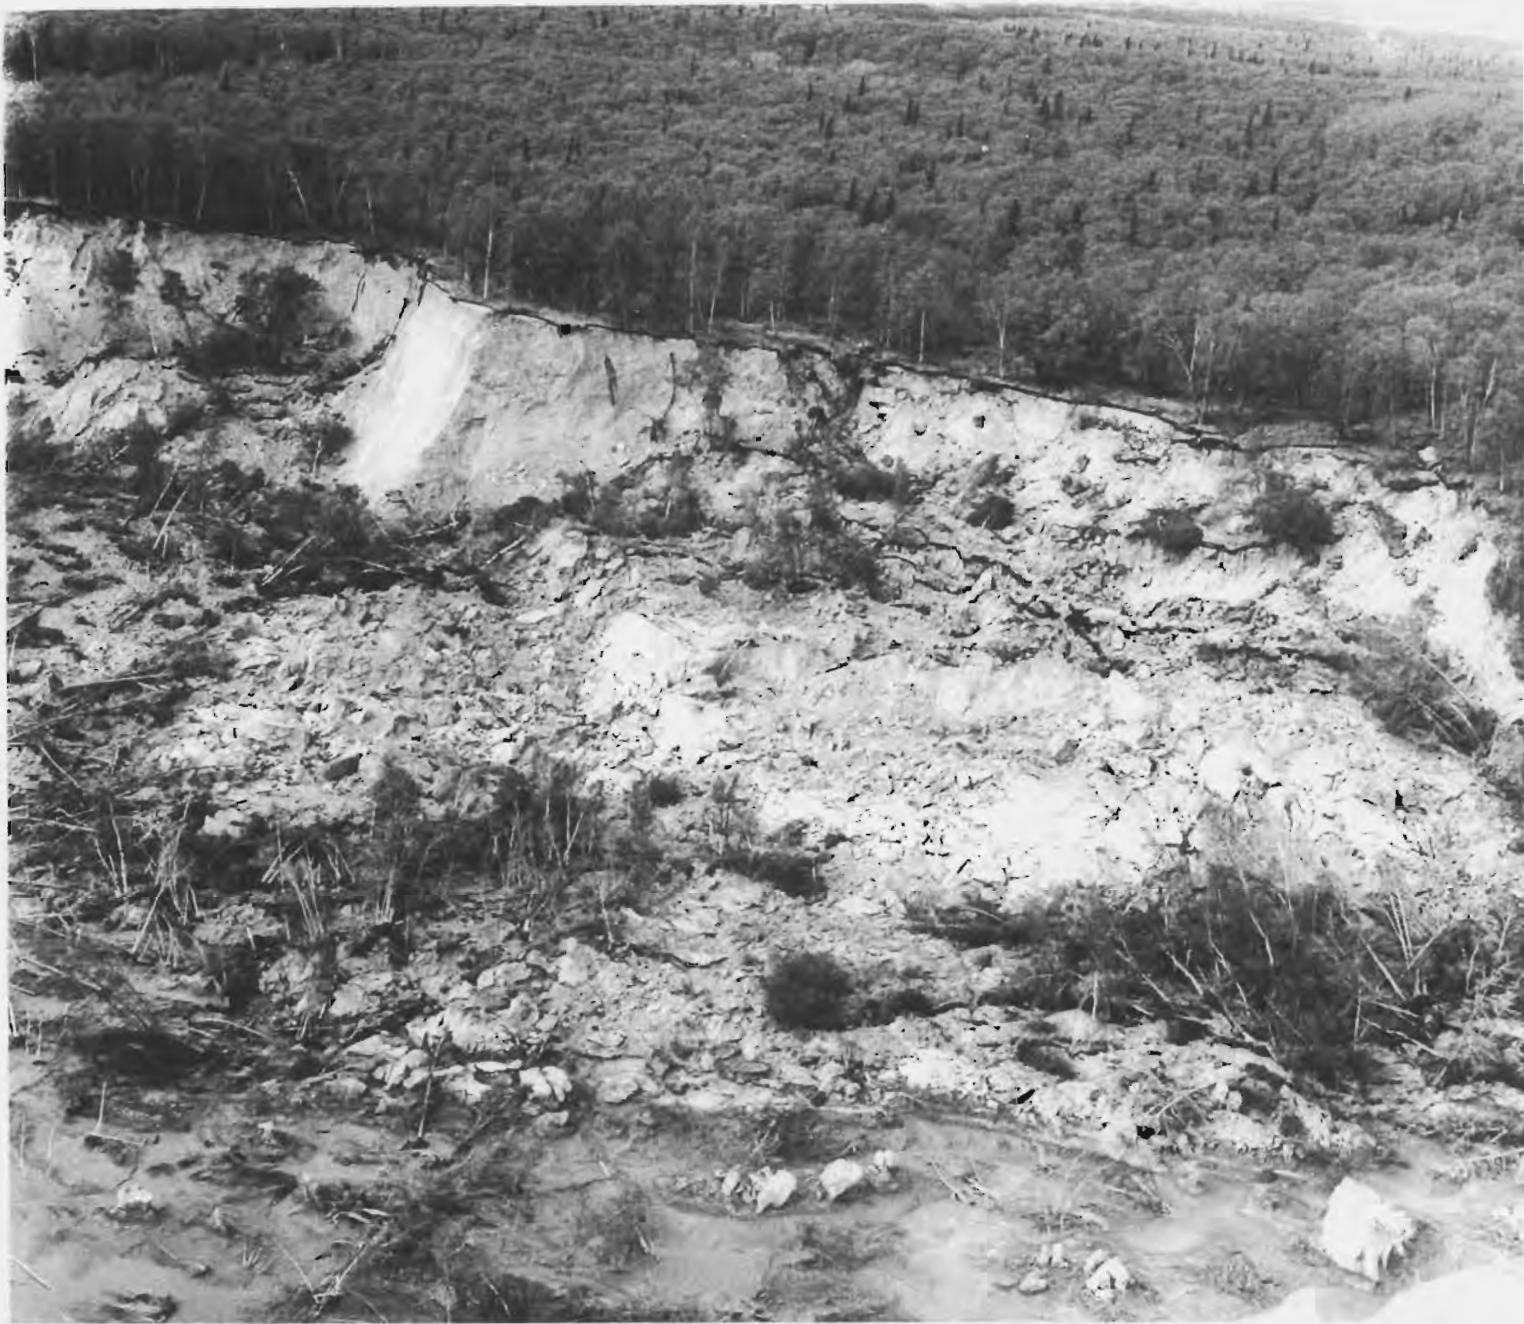
19.—Rotational slump near Sleeper landing strip, on the west side of Knik Arm opposite Cairn Point. At its foot, the slump passed into an earthflow. Tidewater in foreground. Scarp to left of upper center is about 80 feet high.

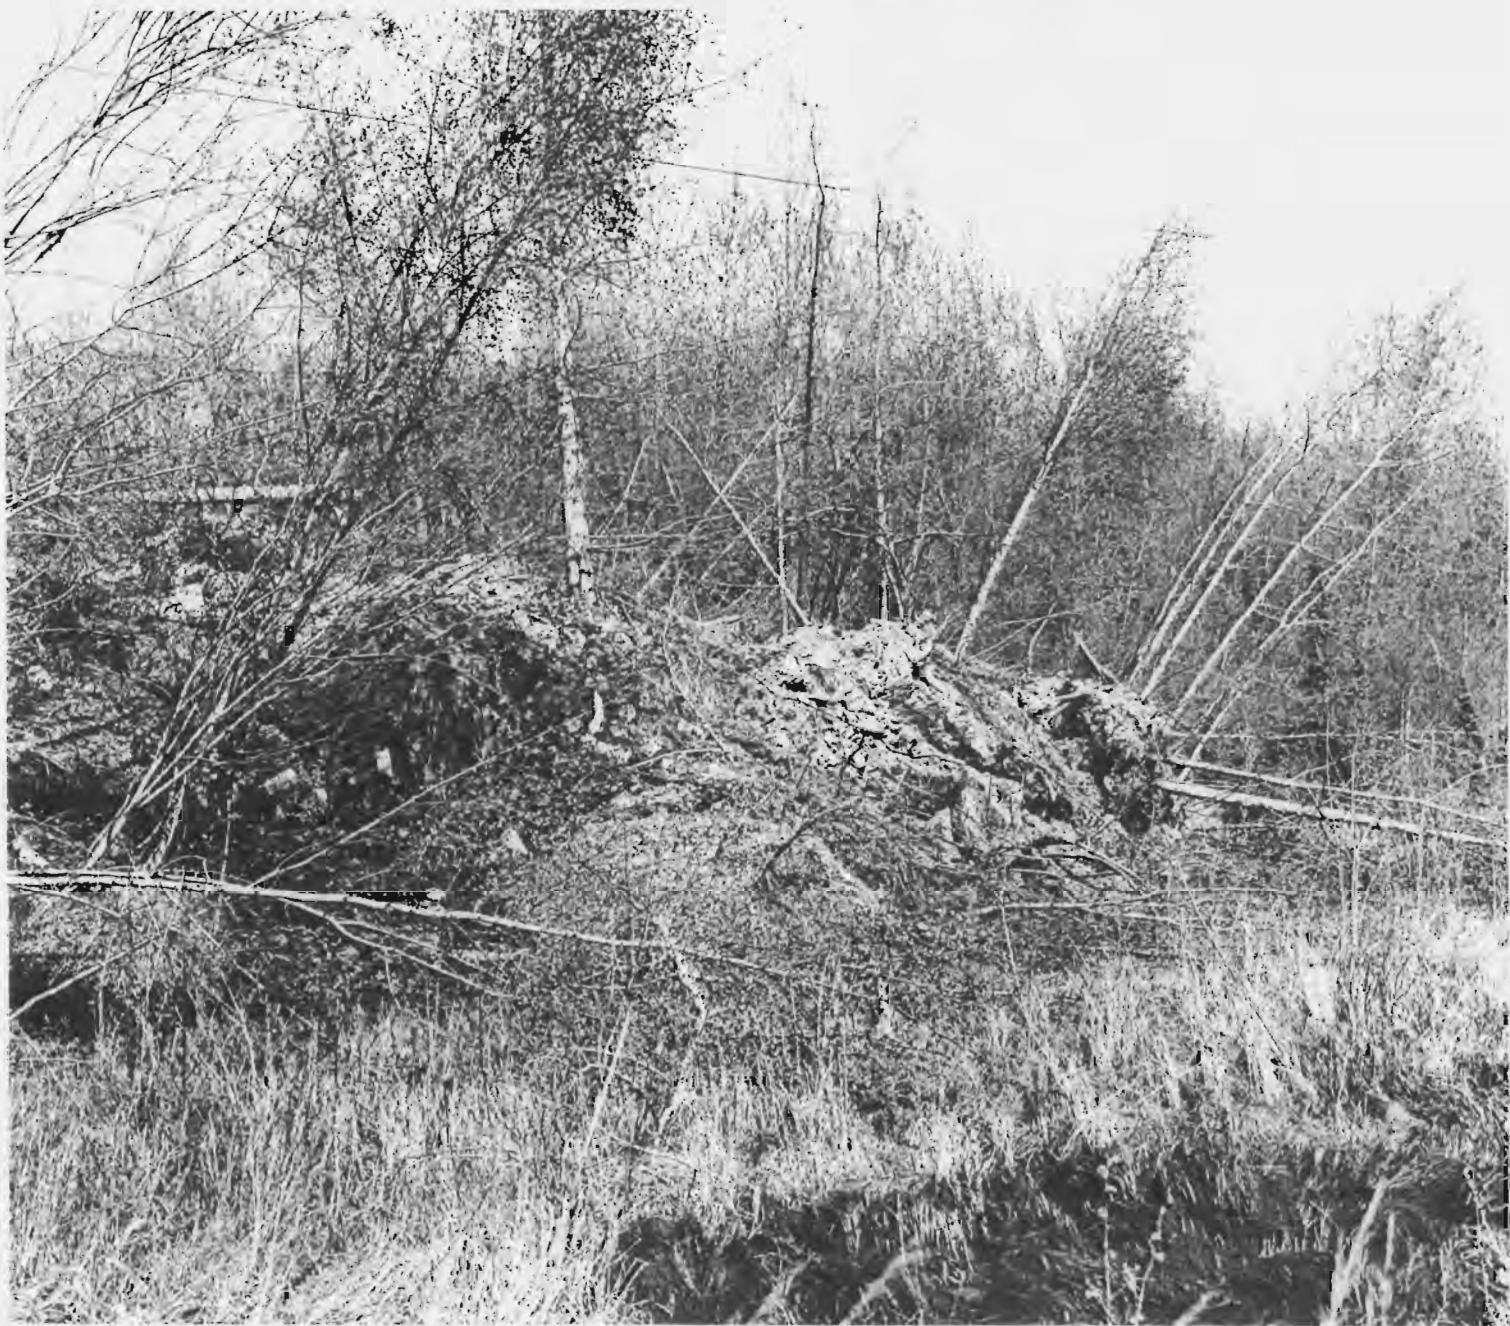
21.—Chaotic pressure ridge at toe of rotational slide, Bluff Road.. In part, toe surged forward as an earthflow. Compare with figure 22.

tion either increased again or the attitude of the blocks became chaotic (fig. 22). In other words, the old ground surface was tilted most near the head and least about halfway to the toe. This differential tilting (in addition to rotation) seems to have been in response to a withdrawal of material from beneath the headward parts of the slumps, either by flowage and extrusion, by lateral spreading, or by a combination of the two. If by a combination, these slides represent a transitional form between the simple slumps of the Point Woronzof and Cairn Point areas and the block-glide displacements in the downtown Anchorage area.

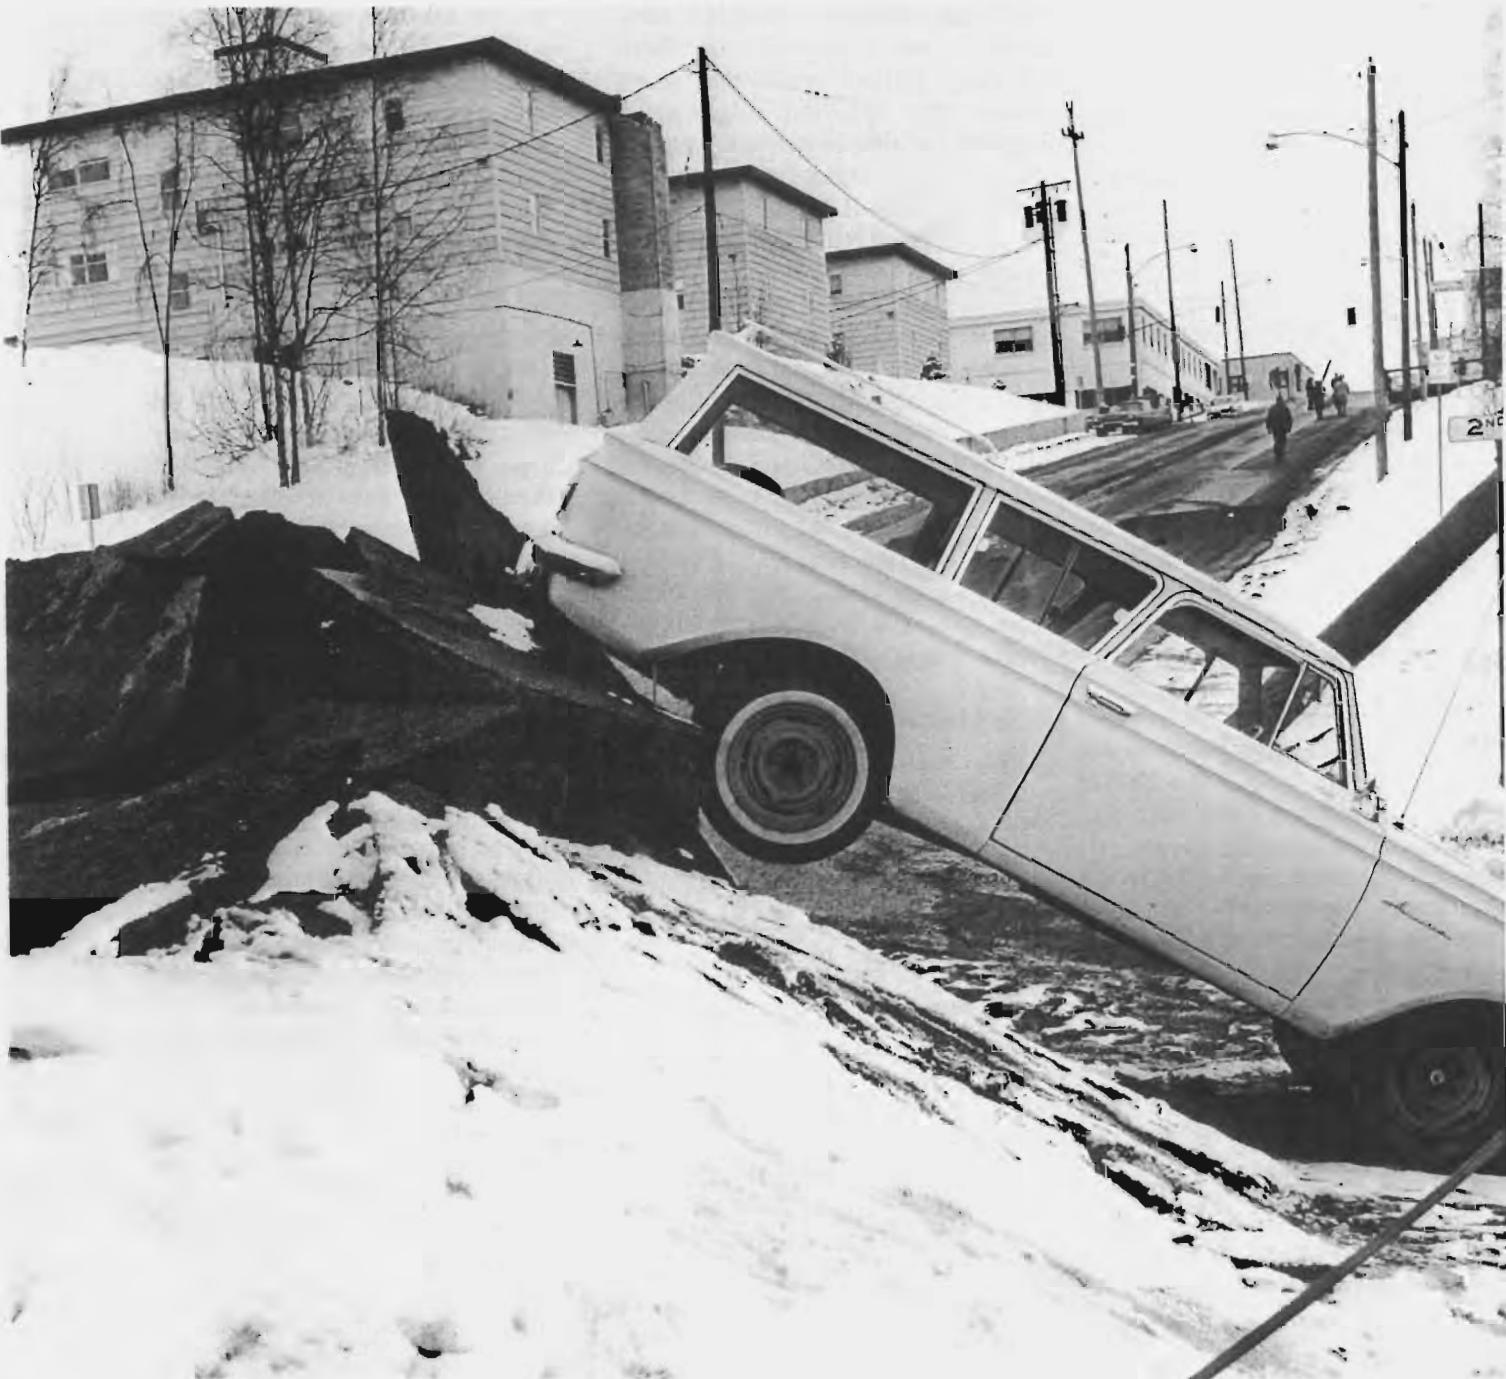
26.—Sharp-crested pressure ridge at Second Avenue and C Street, Anchorage. Probably caused by shallow translation of frozen surface layer. Note smaller pressure ridge in street part way up block and toppled chimney of building behind car. Photograph by Mac's Foto, Anchorage.
