Issues the Core Team Needs to Address

Raymond C. Vaughan

January 15, 2008

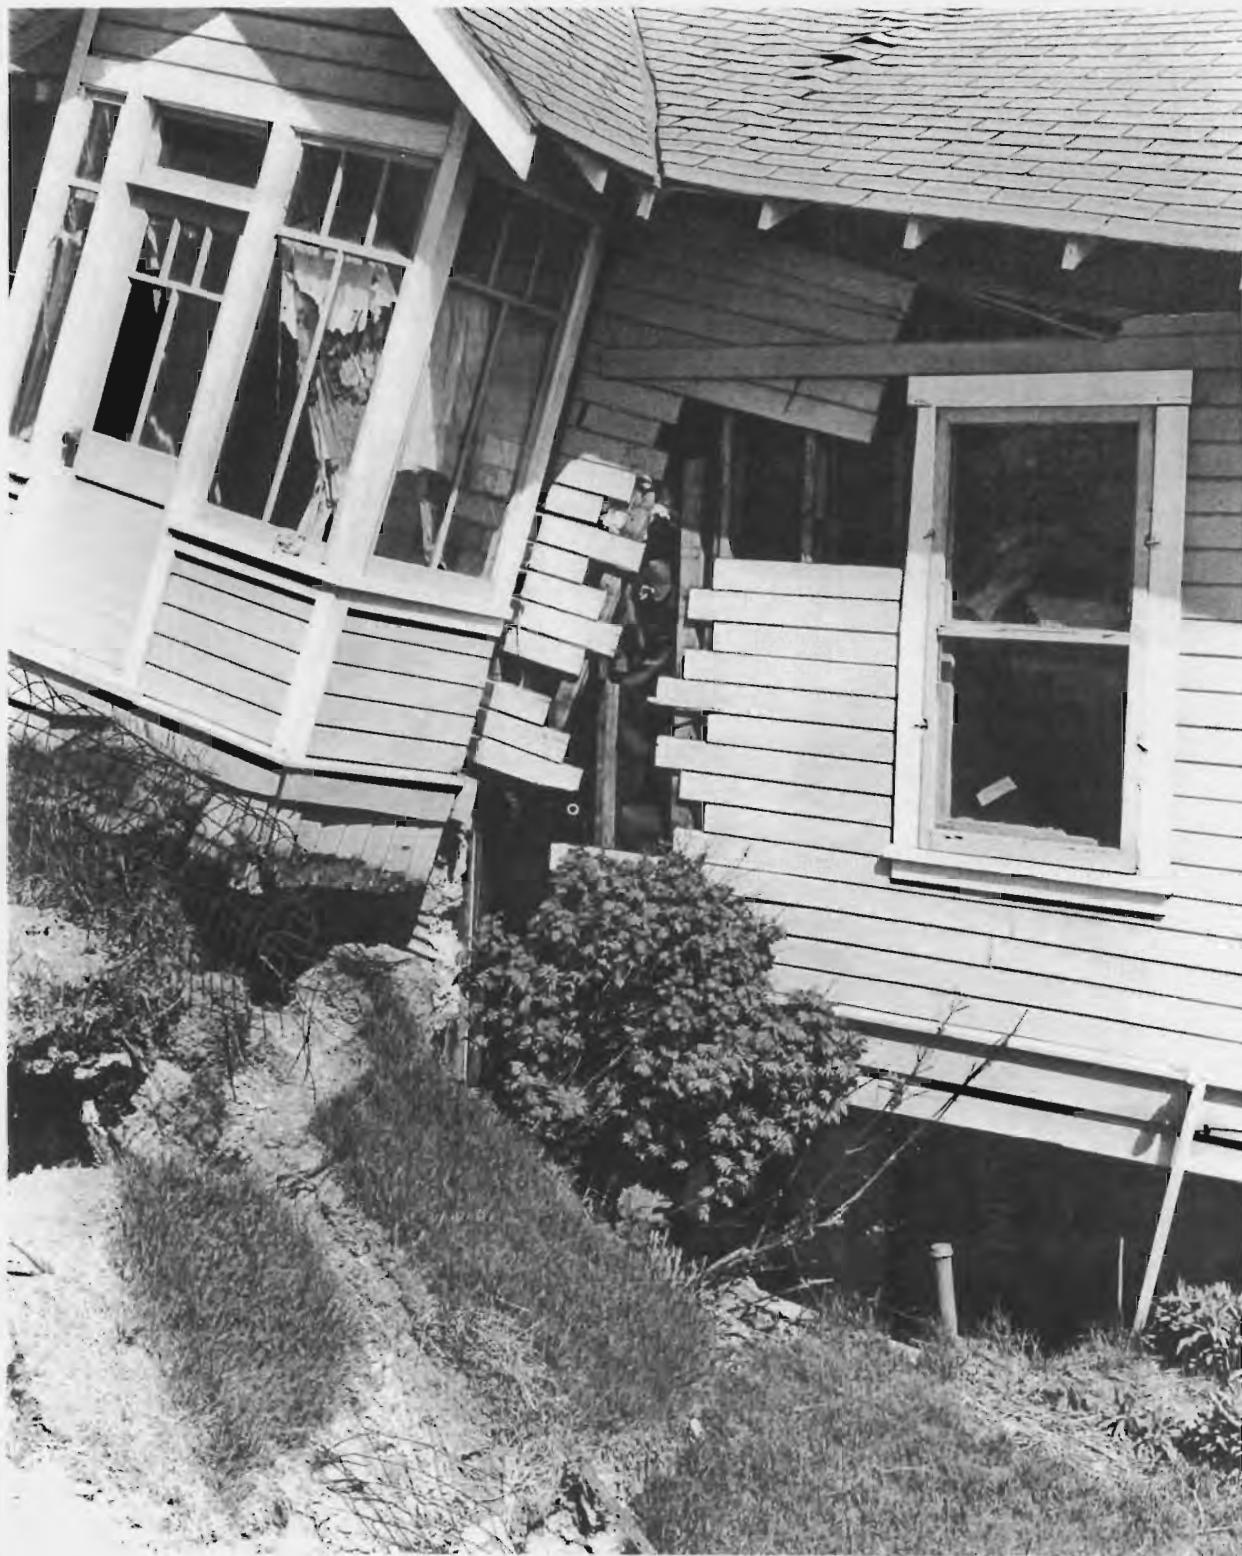
28.—Wrecked dwelling astride bounding fracture, L Street graben at Eighth Avenue and N Street. Damage caused entirely by ground displacement along fracture.

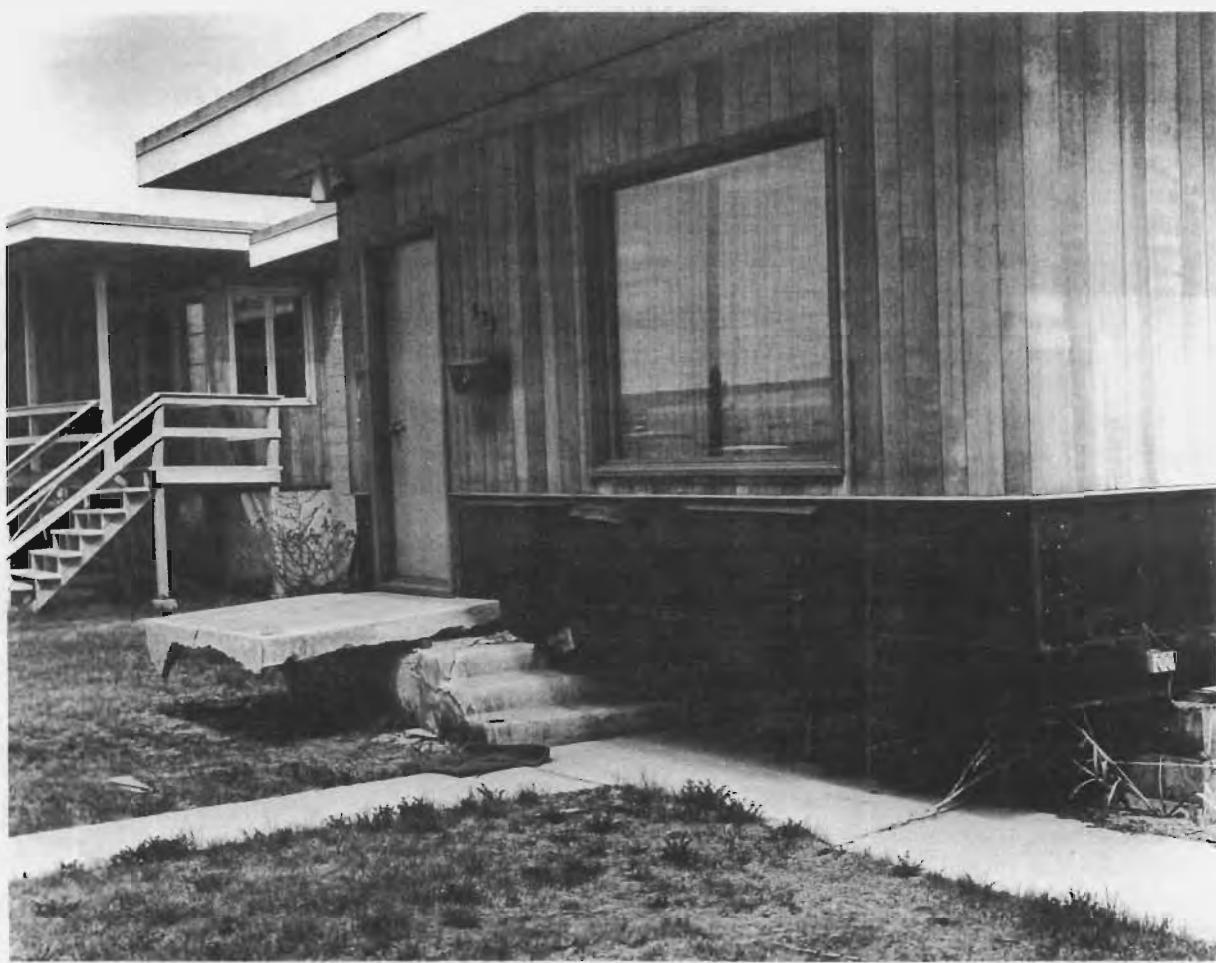
29.—House pushed off foundation by pressure ridge at toe of L Street slide. Well-framed house not otherwise visibly damaged. Push must have been shallow and nearly horizontal.

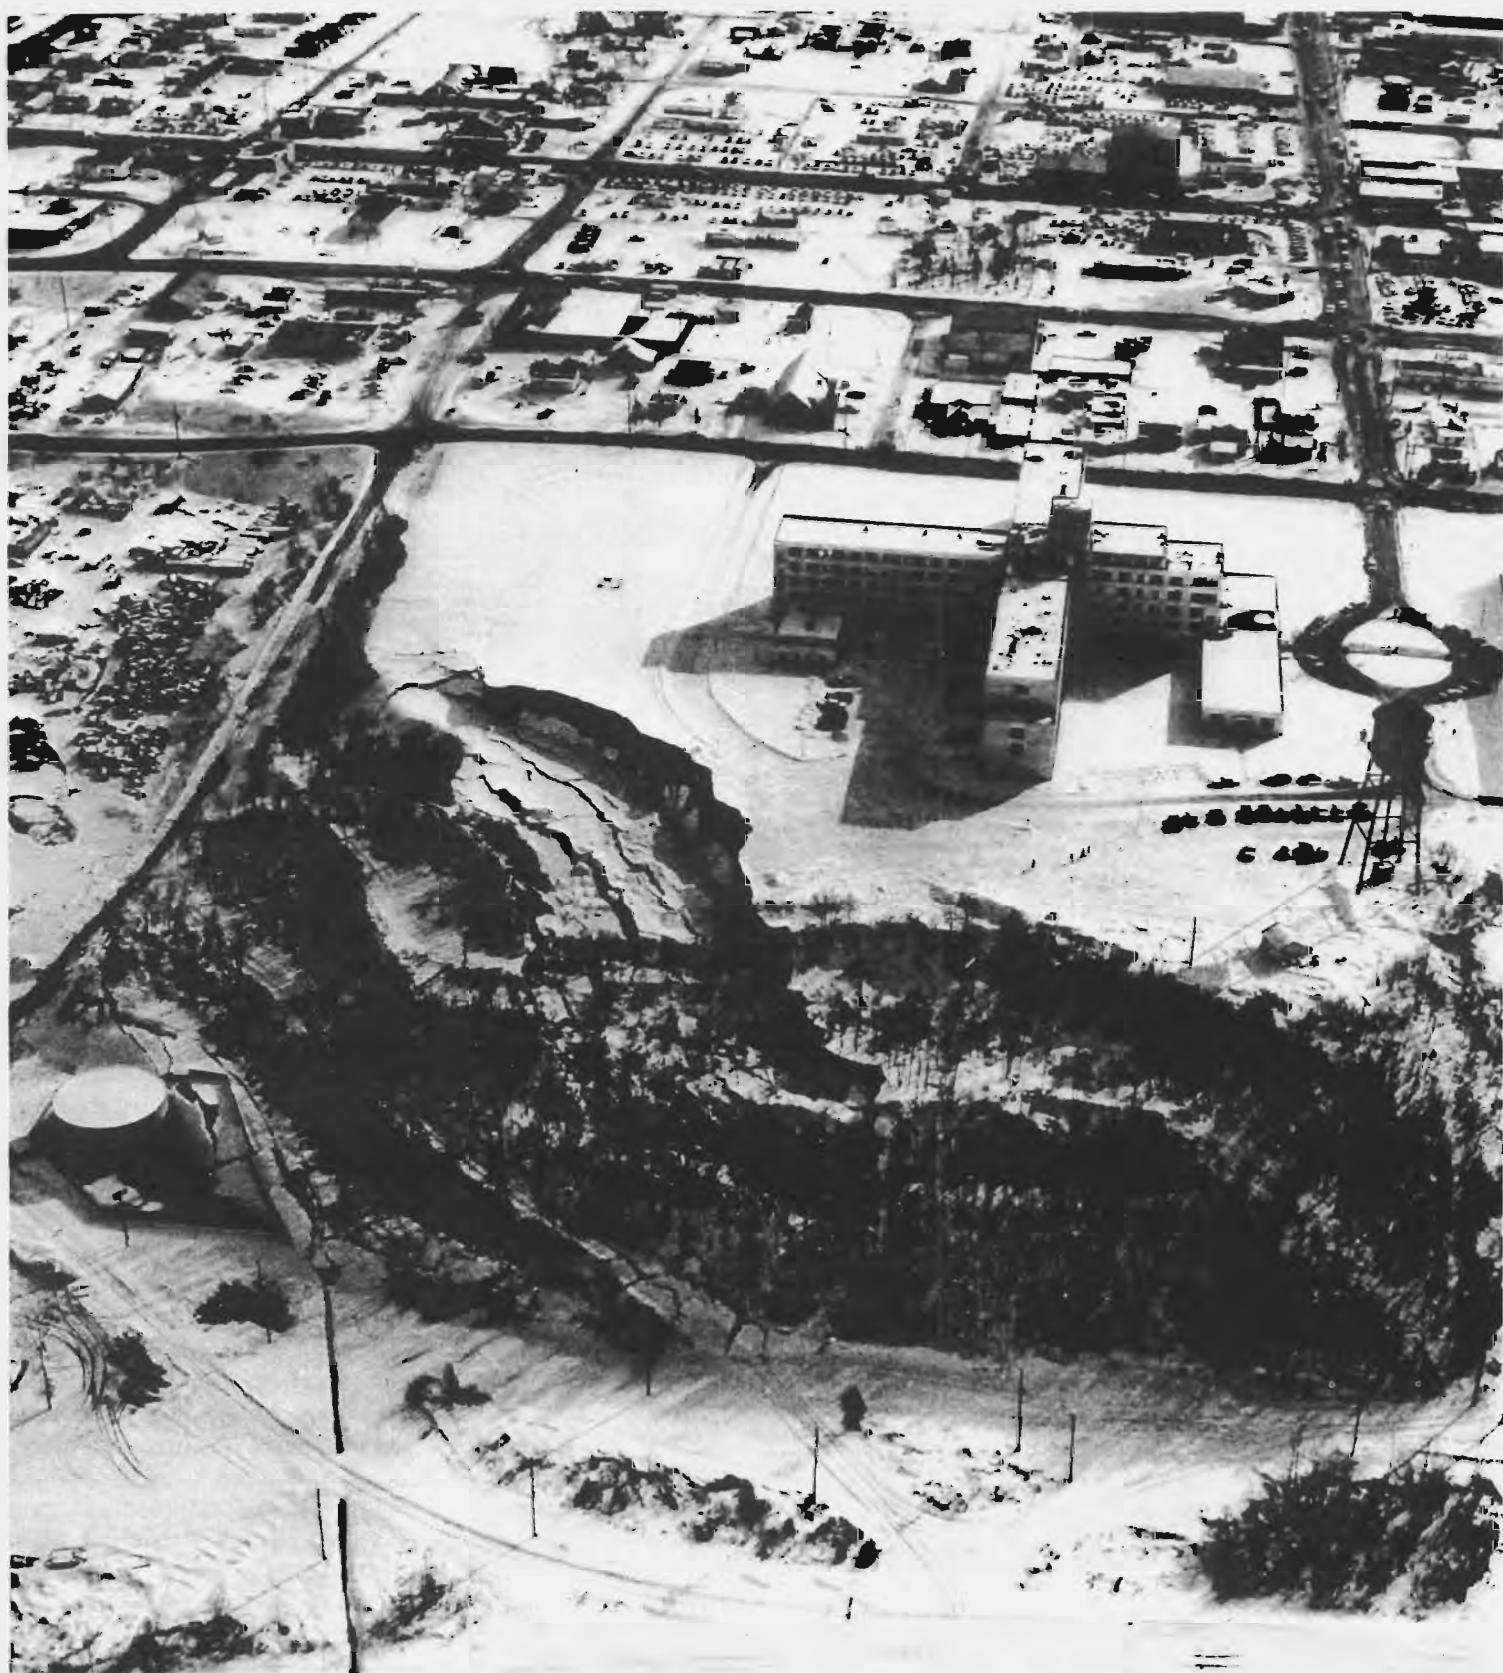
32.—Air view (looking south) of Native Hospital slide showing graben and pressure ridge. The scar of an older landslide is transected by the slide of March 27, 1964. Photograph by U.S. Army.

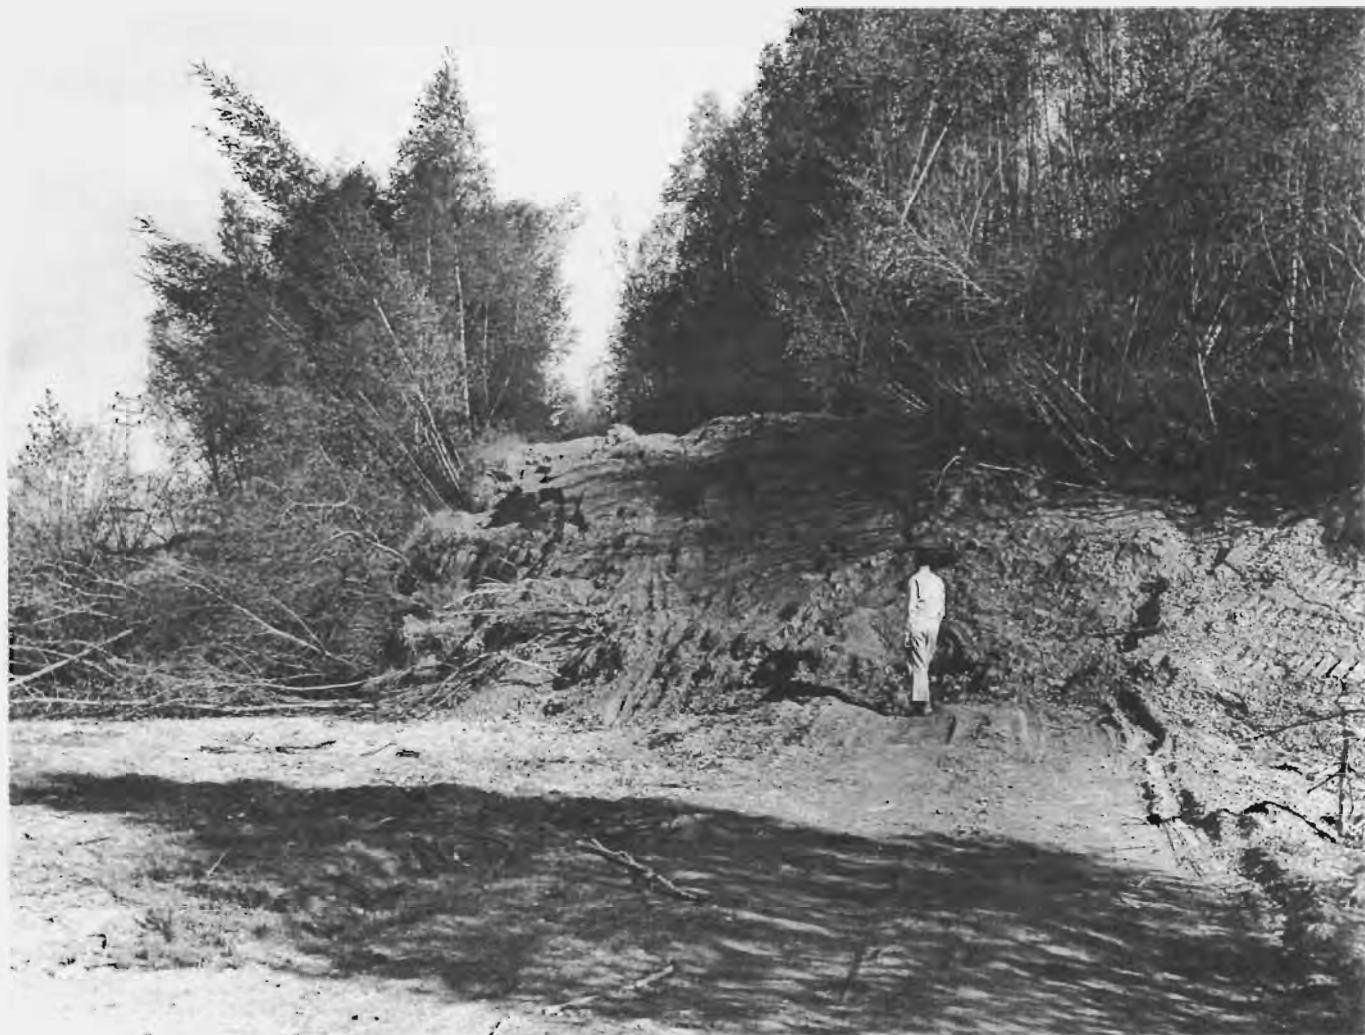
34.—Overthrust toe of Native Hospital slide. Road is bulged up and displaced about 12 feet laterally. Note overridden trees at left.

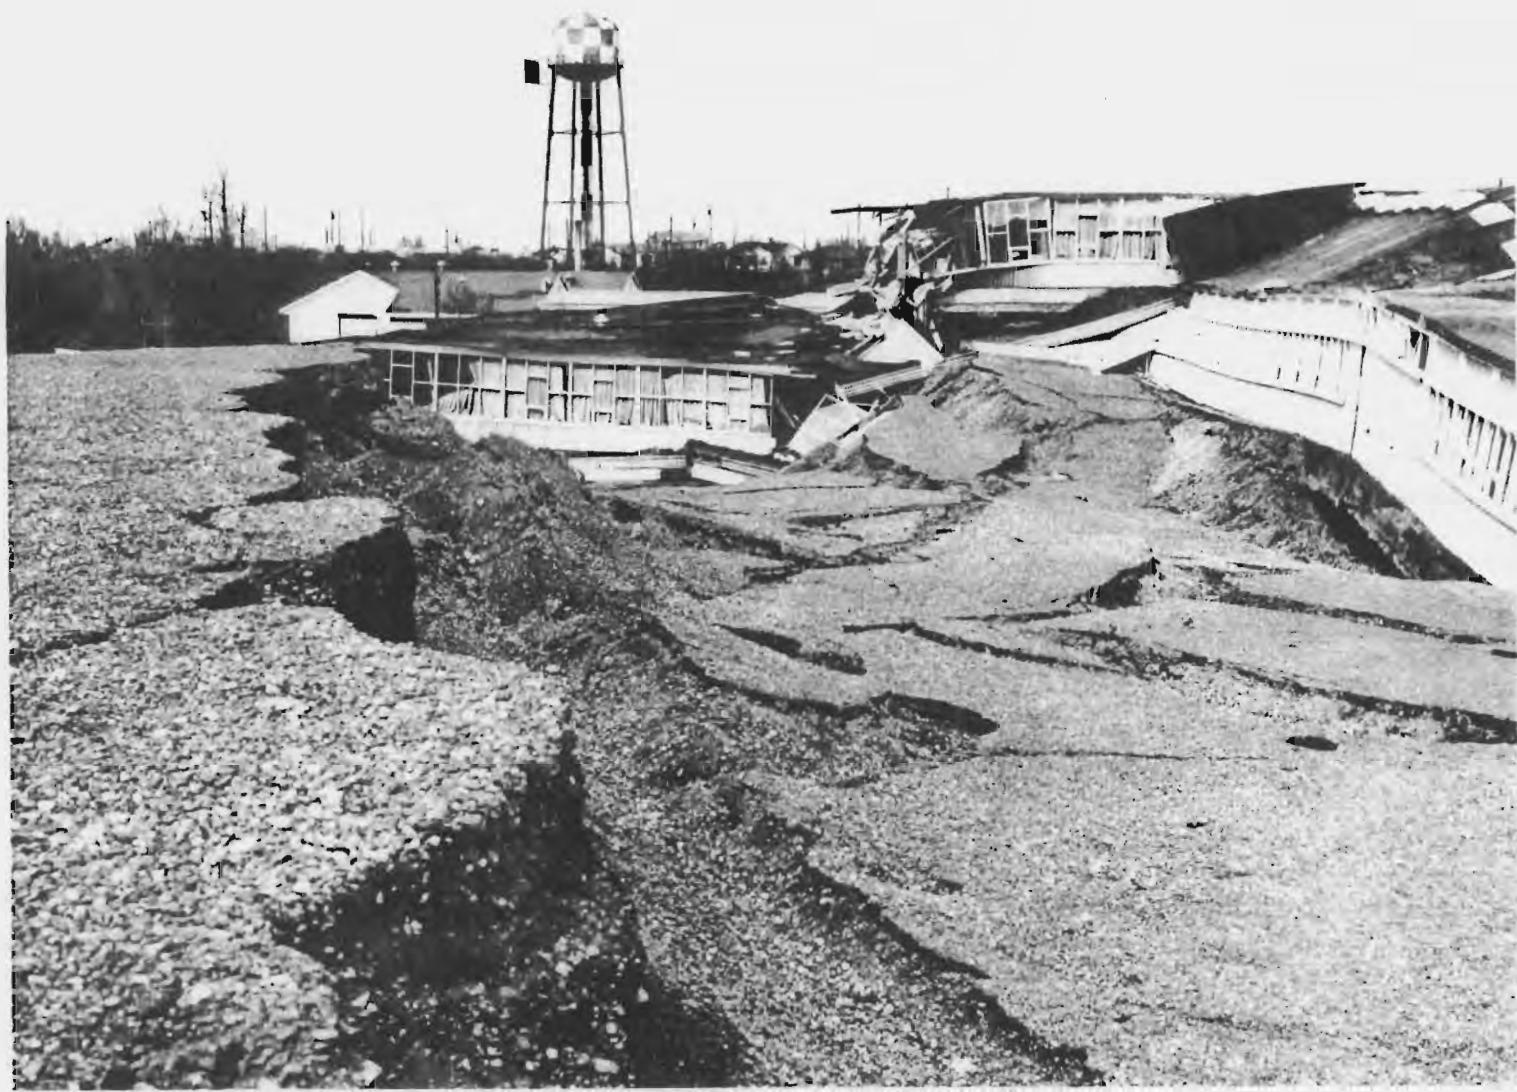
36.—Wreckage of Government Hill School as viewed from the playground, looking west. Graben in foreground is about 12 feet deep. Note undamaged water tower.

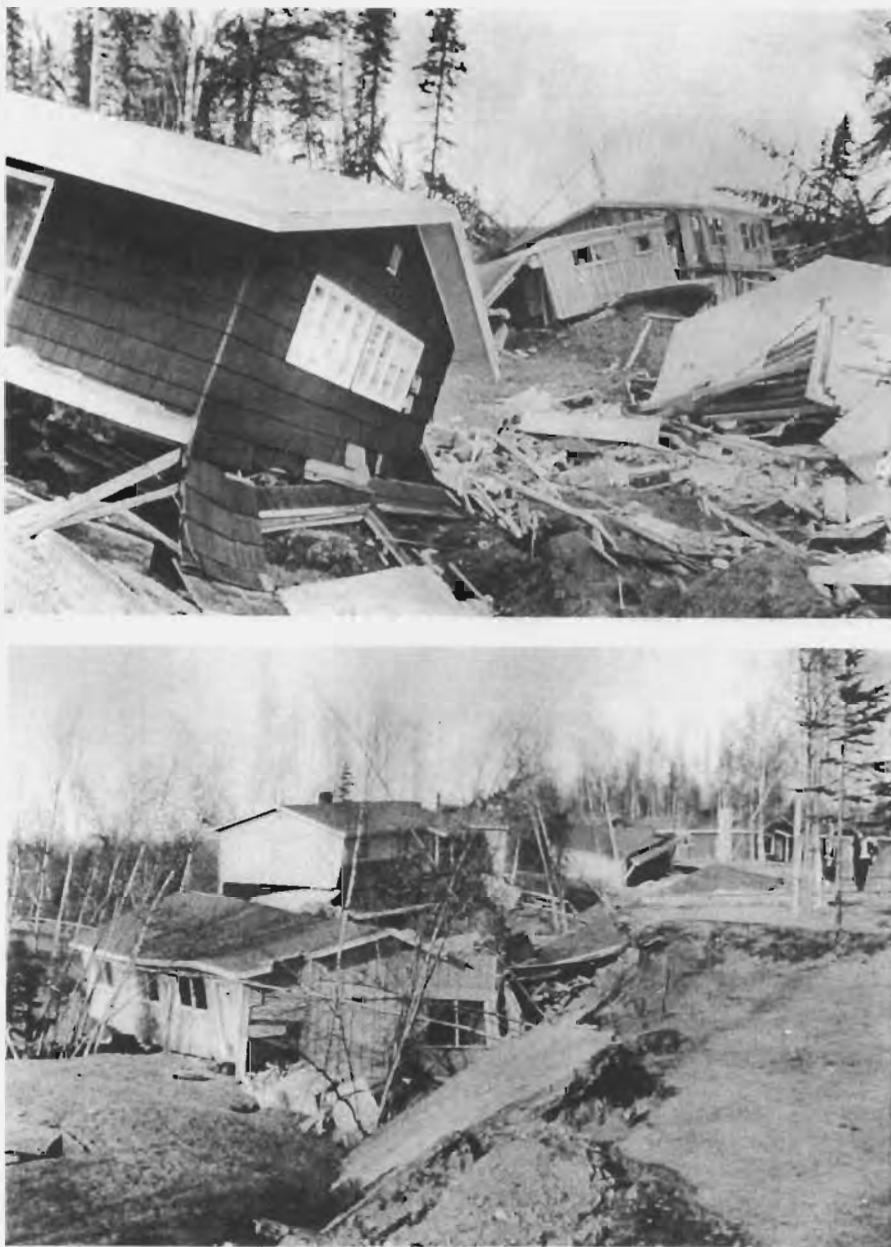
39.—Homes devastated by Turnagain Heights slide; deep within slide area, upper; at main scarp, lower. About 75 homes were destroyed.

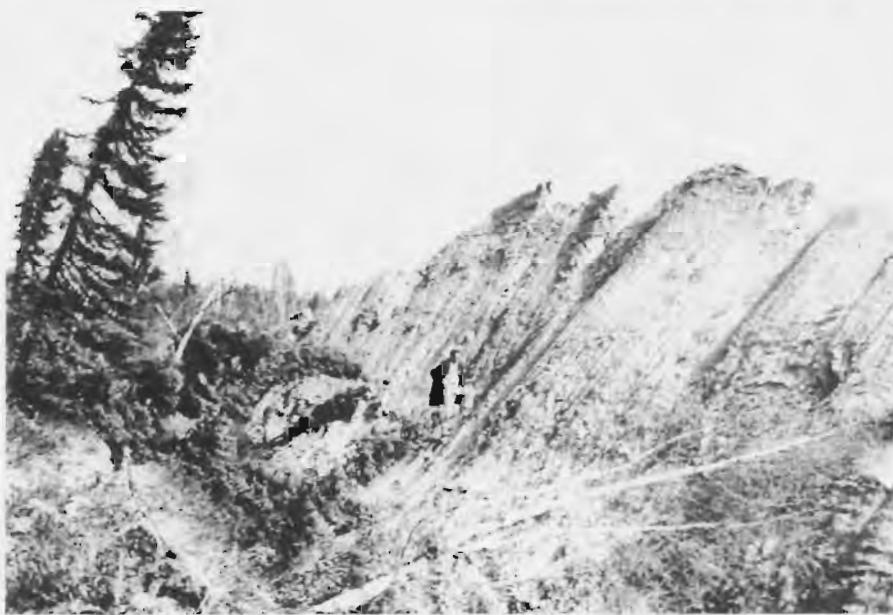
41.—Furrowed, slicksided clay ridge, Turnagain Heights slide. Ridge is about 20 feet high. Tilted collapsed block at left. Compare with figure 42.

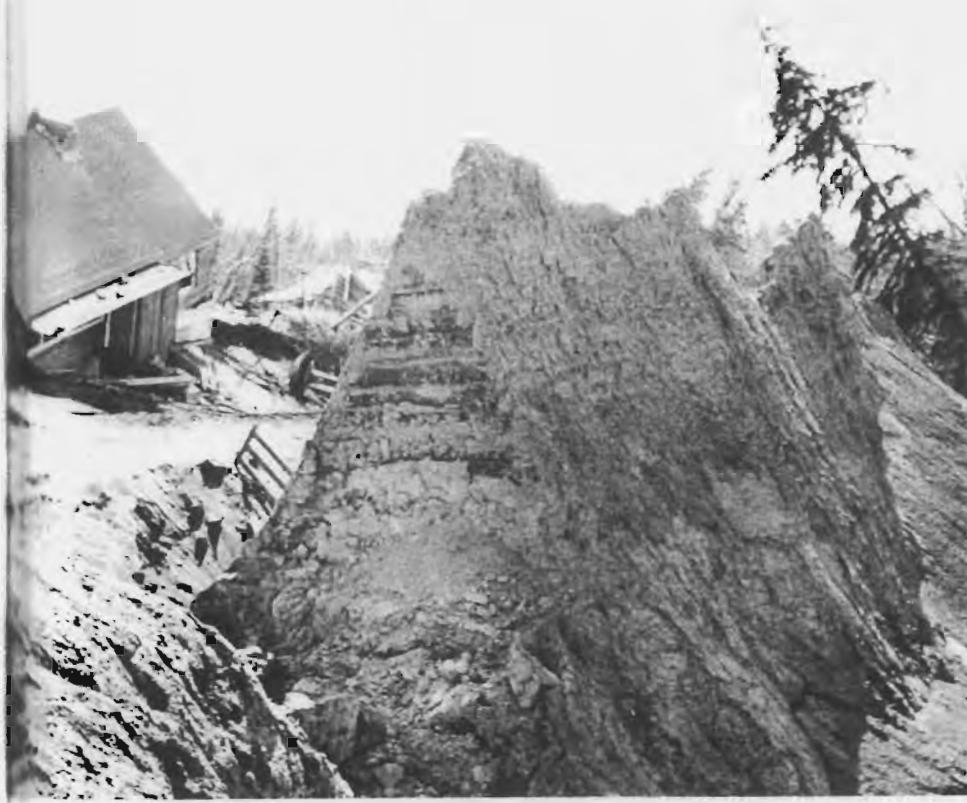
42.—Sharp-crested clay ridge, Turnagain Heights slide. Collapsed blocks tilted toward ridge on both flanks. Note horizontal stratification in ridge. Compare with figure 41.

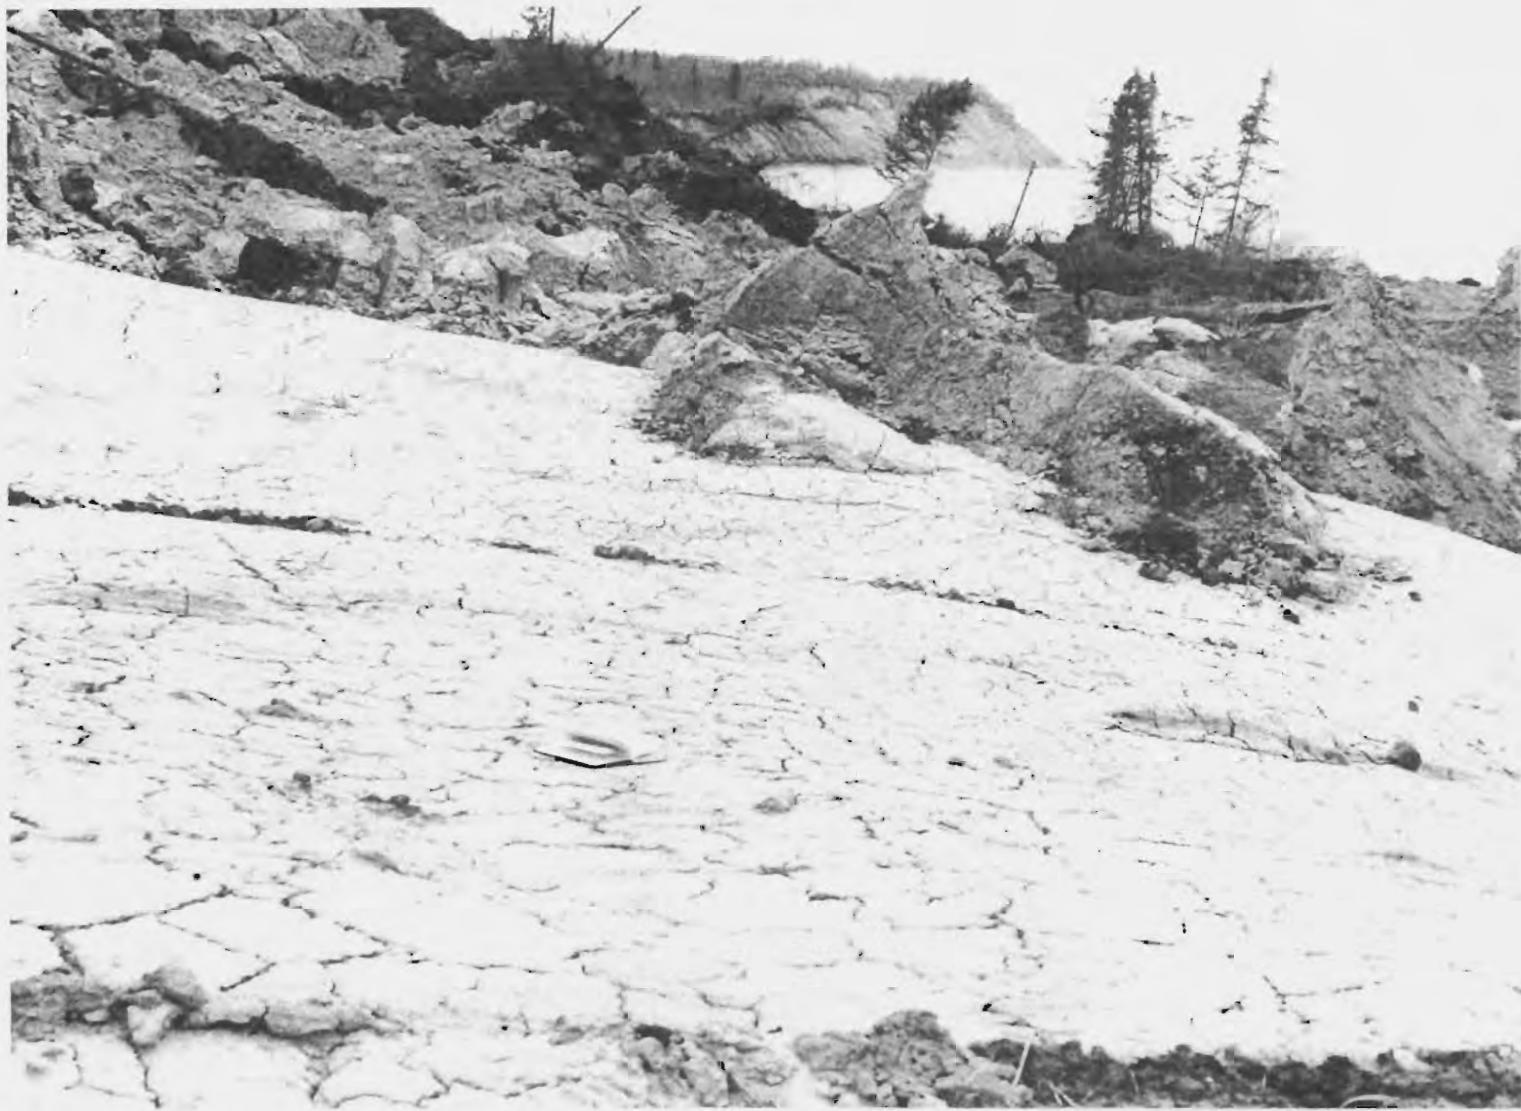
43.—Slip surface of Turnagain Heights slide exposed near west margin of slide. Furrows and wefts still well preserved despite desiccation and weathering. Point Woronzof and Knik Arm in distance.

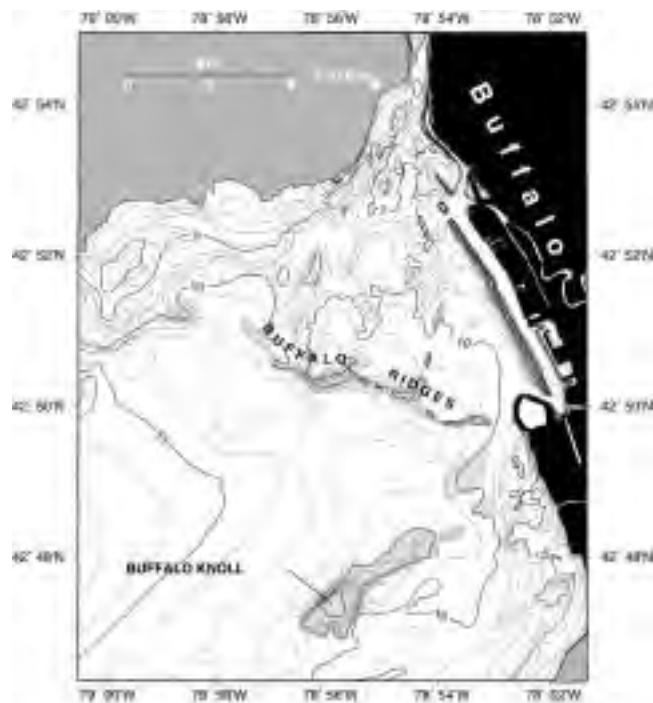
FIG. 1a. Bathymetry of the eastern end of Lake Erie showing the Buffalo Ridges and Buffalo Knoll. The two features are highlighted in gray. Contour interval 1 m.
