## State-Licensed Disposal Area (SDA)

Tom Attridge - Program Manager

## Location of the SDA

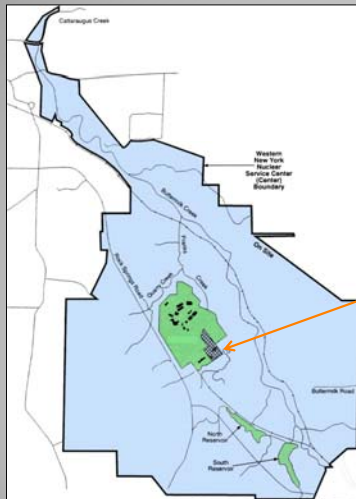
- Approximately 15 acres adjacent to the West Valley Demonstration Project
- NYSERDA has 100% management responsibility for the SDA

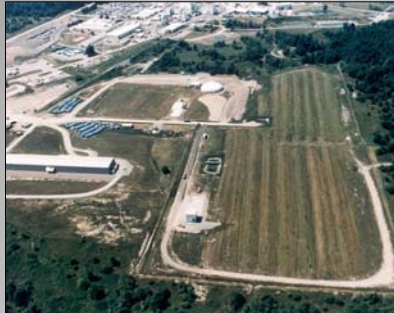
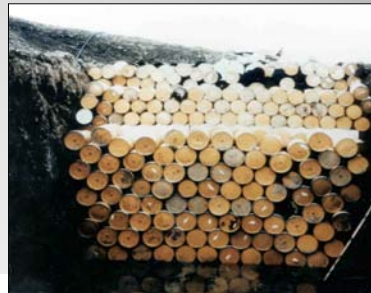
## Operational History of the SDA

- ~ 736,000 curies of radioactivity was disposed of in the trenches
- Water infiltration caused the trenches to overflow in 1975 and disposal operations were terminated

- Commercial radioactive waste disposal facility – operated by Nuclear Fuel Services from 1963-1975
- 2.4 million cubic feet of waste was disposed in the 14 trenches at the SDA

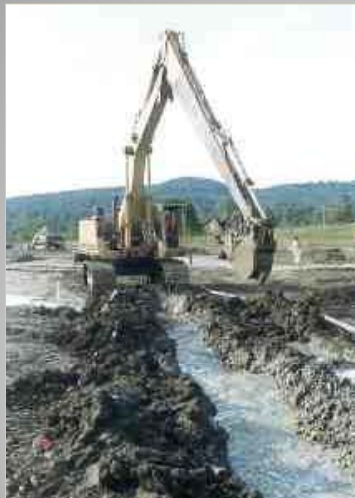
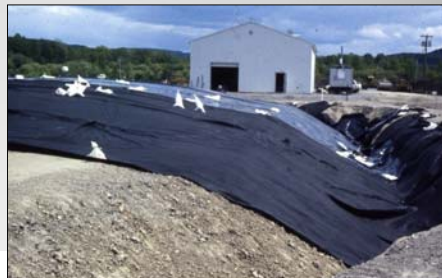
## NYSDERDA Management History

- NYSDERDA assumed day-to-day management responsibility for the shutdown facility in 1983
- Water infiltration controls installed by NYSDERDA in the 1990s has stopped water from accumulating in the trenches

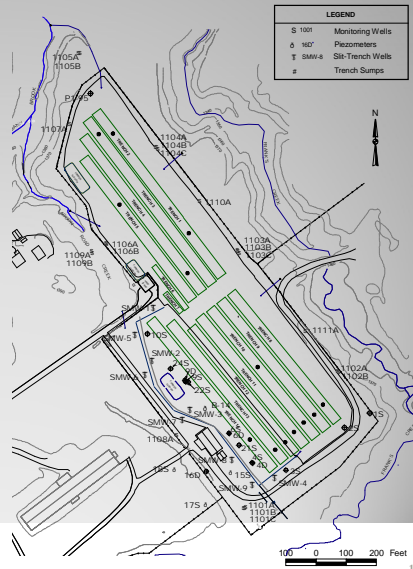
- **Radiation Control Permit, RCRA 3008 (h) Consent Order**
- **21 Groundwater Monitoring Wells**
  - ❖ Semiannual sampling for detection of radionuclides and volatile organic compounds
  - ❖ Three geologic units are monitored - Weathered Lavery Till, Unweathered Lavery Till and Kent Recessional Unit
- **2008 Groundwater Results**
  - ❖ Results did not exceed regulatory groundwater quality standards (6 NYCRR Part 703)

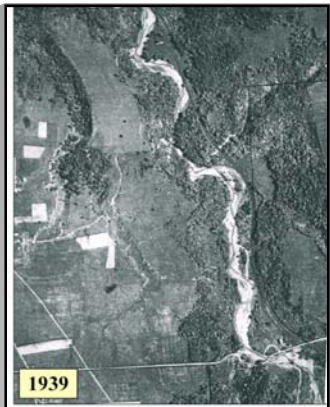
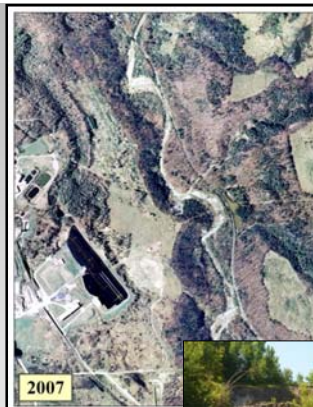
### > Buttermilk Creek Landslide

- ❖ Buttermilk Creek watershed erosion processes
- ❖ Monitoring can inform future erosion modeling

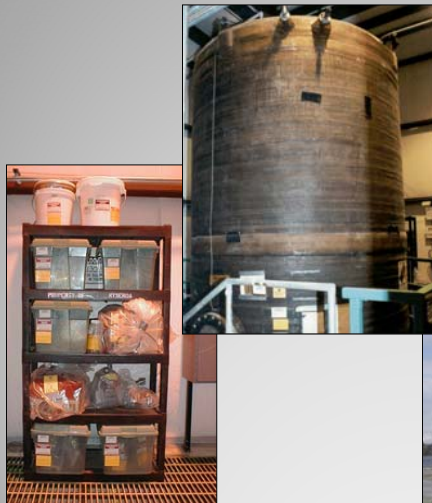
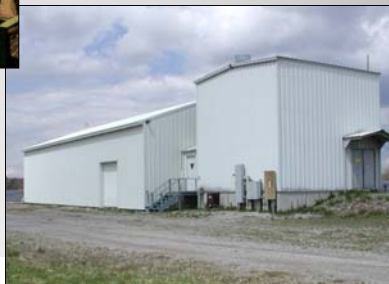
## Waste Generation

- NYSERDA does not routinely generate radioactive waste
- ~ 8,000 gallons of leachate is stored in the Tank T-1 Building
- Solid waste (e.g. pumps, motors, filters, etc.) stored in Tank T-1 Building
