# Thomas Corners Road Bridge Replacement

July 2013

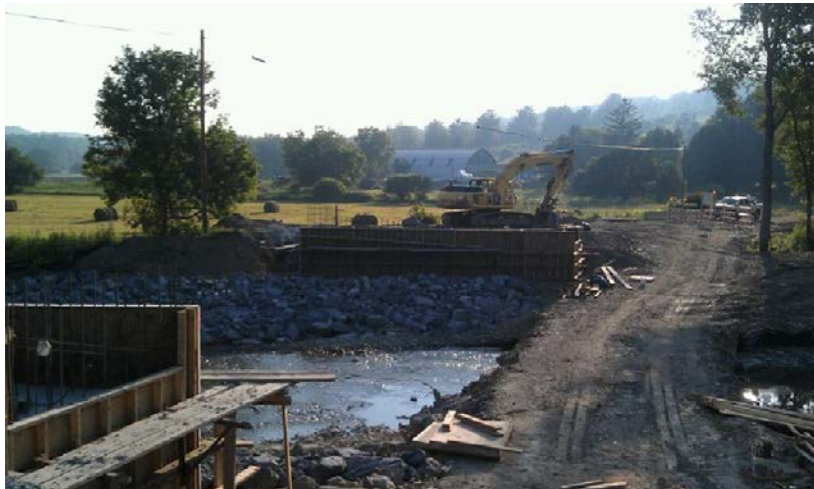
Bridge Construction as of 7-18-13

- Cattaraugus County began demolition work June 6, 2013
- NYSERDA provided radiation survey coverage during potentially impacted soil/sediment disturbance activities
  - Surveys included soils, sediments, construction debris, and equipment
  - No contamination was discovered during demolition activities
  - All demolition debris met acceptance criteria for disposal in a New York State landfill
- NYSERDA will continue to provide radiation survey coverage as needed; e.g., surveys to support bank stabilization work
