# West Valley Demonstration Project Decommissioning Status

**Bryan Bower**  
Department of Energy

Citizen Task Force Meeting  
January 22, 2014

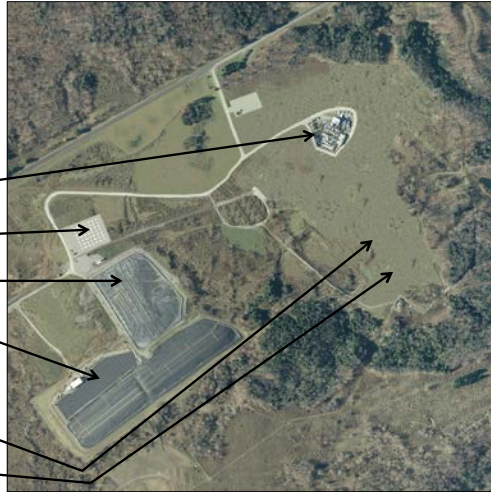
At the end of Phase 1 decommissioning (Phase 1 facility disposition plus Phase 1 soil remediation) six facilities/ areas will remain:

- Tank farm with the tank and vault drying system
- HLW storage casks
- NDA with cap and barrier wall
- SDA with cap and barrier wall
- Non-source area of groundwater plume
- Construction and Demolition Debris Landfill

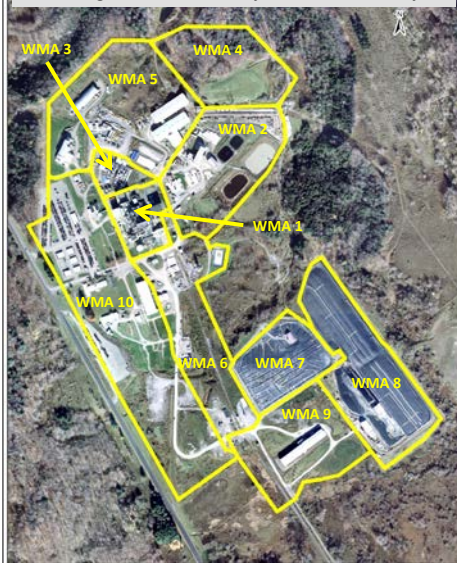
Orthoimage of the West Valley Demonstration Project

The *Final Environmental Impact Statement for Decommissioning and/or Long-Term Stewardship at the West Valley Demonstration Project and Western New York Nuclear Service Center* addresses the developed portion of the site in 10 waste management areas (WMA)

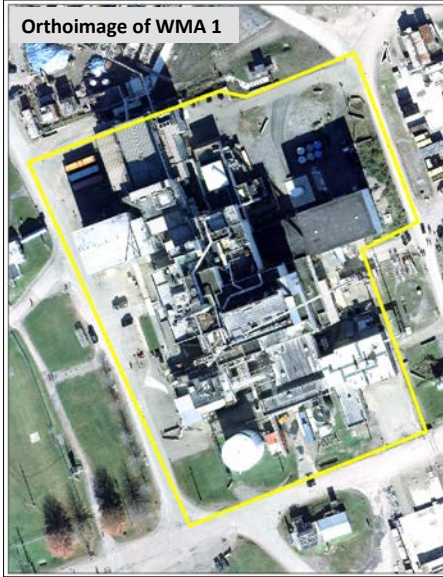
Orthoimage of WMA 1

### WMA 1 includes:

- Main Plant Process Building (MPPB)
- Plant office building
- Vitrification Facility
- Load-in/Load-out Facility
- Utility Room
- Fire Pump House
- Water storage tank
- Laundry
- Fuel Receiving and Storage

Facility	January 2014 Status	Planned for End of Phase 1 Facility Disposition	Planned for End of Phase 1 Decommissioning
Main Plant Process Building	Removed: 86% of contaminated vessels 84% of piping and conduit 95% of asbestos	Demolished to slab at grade	Removal of slab, below-grade structures, & source area of plume
Vit Facility	99% decontaminated: contaminated equipment removed, floor cleaning & electrical isolations underway; cold chemical building demolished to the slab	Demolished to slab at grade	Removal of below-grade structures
Fuel Receiving & Storage	Vent building demolished; pool drained and cleaned; surface & airborne contamination remain	Remains in place	Removal of above- and below-grade structures
Plant Office Building	Rooms emptied, asbestos removal underway	Demolished to slab at grade	Removal of below-grade structures

Facility	January 2014 Status	Planned for End of Phase 1 Facility Disposition	Planned for End of Phase 1 Decommissioning
Utility Room	In service, contains significant quantity of asbestos	Demolished to slab	Removal of below-grade structures
Load-in/Load-out	In service, available for load-out of HLW canisters	Demolished to the slab	Removal of below-grade structures
Water Storage Tank & Fire Pump House	In service	Operational	Removal of above- and below-grade structures
Laundry Room	Demolition Ready	Demolished to the slab	Removal of below-grade structures
01-14 Building	Demolished to the slab	Demolished to the slab	Removal of below-grade structures

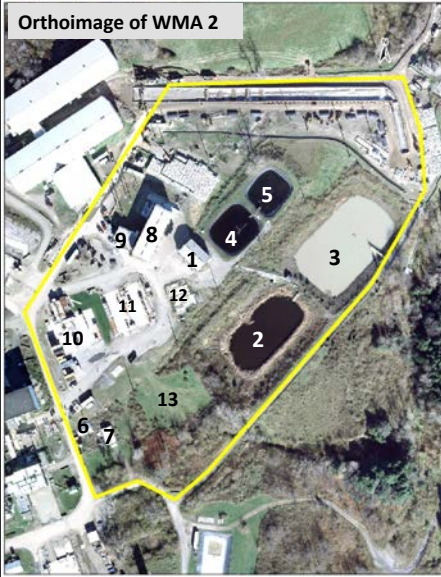
## WMA 2

1. Low-Level Waste Treatment Facility 2 (LLW2)
2. Lagoon 2
3. Lagoon 3
4. Lagoon 4
5. Lagoon 5
6. Old interceptor
7. New interceptors
8. Vitrification Test Facility
9. Vehicle Repair Shop
10. Test and Storage Building
11. Maintenance Shop
12. O2 building
13. Lagoon 1 area

Facility	January 2014 Status	Planned for End of Phase 1 Facility Disposition	Planned for End of Phase 1 Decommissioning
Low-Level Waste Treatment Facility 2 & Lagoons 2, 3, 4 & 5	Operational	Operational	Removal
Old & new interceptors	Operational	Operational	Removal
Vitrification Test Facility	Operational	Facility & foundation removed; area restored	NA
Vehicle Repair Shop, Test & Storage Building, Maintenance Shop	Demolished to slabs at grade	Facilities removed, foundations remain	Removal
O2 Building	Demolished to slab at grade	Foundation removed; area restored	NA
Lagoon 1	Inactive	Inactive	Removal

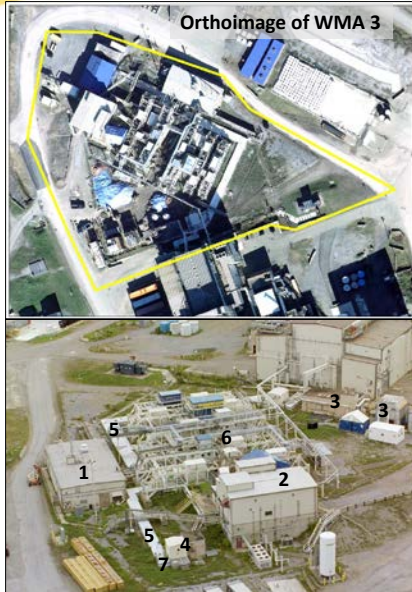
## WMA 3

1. Permanent Ventilation System building
2. Supernatant Treatment System support building
3. Equipment shelter and condensers
4. Con-Ed building
5. High-Level Waste (HLW) transfer trench
6. Two underground, 760,000 gallon carbon steel tanks: 8D-1 and 8D-2
7. Two underground, 14,300 gallon stainless steel tanks: 8D-3 and 8D-4

Facility	January 2014 Status	Planned for End of Phase 1 Facility Disposition	Planned for End of Phase 1 Decommissioning
Permanent Ventilation System	Operational	Operational	Operational
Supernatant Treatment System Support Building	Operational	Operational	Remains in place
Equipment Shelter (ES) & Condensers	Condensers isolated; ES partially operational	Facilities removed; foundation remains	Removal of foundation
Con-Ed Building	In-active	Facility removed; underlying tanks remain	NA
High-Level Waste Transfer Trench	In-place	All lines & trench isolated	Remove piping; trench remains
Tanks 8D-1 & 8D-2	Isolated	Isolated	Remain in place
Tanks 8D-3 & 8D-4	Isolated	Isolated	Remain in place

- Tank & Vault Drying System (T&VDS) installed and operational in December 2010
  - Status of tank liquids
    - Tank 8D-1 – all liquid evaporated
    - Tank 8D-2 – all liquid evaporated
    - Tank 8D-3 – all liquid evaporated
    - Tank 8D-4 – 4,630 gallons of liquid/sludge remain
  - Status of vaults and containment pans
    - Tank 8D-1 vault liquid is below level indicator (<2 inches and may be dry)
    - Tank 8D-2 vault liquid is below level indicator (<2 inches and may be dry)
    - All liquid in containment pans of tanks 8D-1 and 8D-2 evaporated
    - Tank 8D-3/8D-4 vault liquid evaporated
- At the end of Phase 1 decommissioning the T&VDS will be operational; tanks and their support structures will remain in place

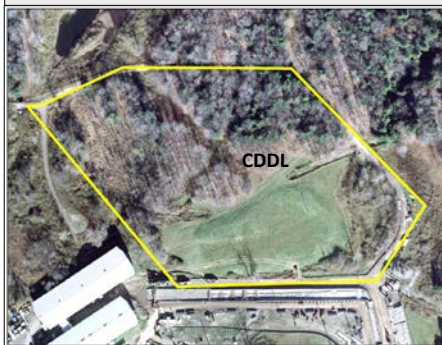
Orthoimage of WMA 4  
Construction & Demolition Debris Landfill

### The Construction and Demolition Debris Landfill (CDDL)

- CDDL is inactive
- Monitoring and maintenance will continue through Phase 1 decommissioning

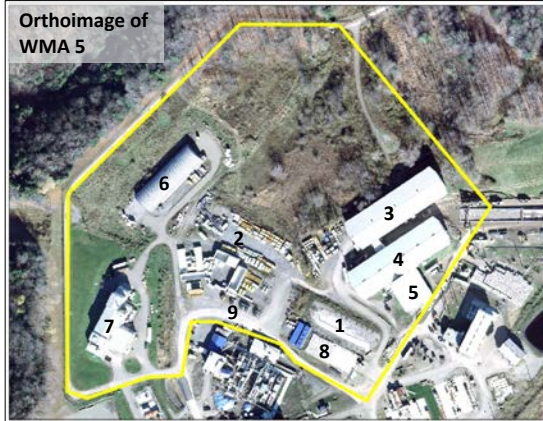
## WMA 5

1. Lag Storage Area 1
2. Lag Storage Area 2
3. Lag Storage Area 3
4. Lag Storage Area 4
5. Shipping depot
6. Chemical Process Cell Waste Storage Area
7. Remote-Handled Waste Facility (RHWF)
8. Lag Storage Building
9. Four Hazardous Waste Storage Lockers

Facility	January 2014 Status	Planned for End of Phase 1 Facility Disposition	Planned for End of Phase 1 Decommissioning
Lag Storage Area 1	Demolished to slab	Foundation remains	Remove foundation
Lag Storage Area 2	Operational	Waste removed; hardstand remains	Remove hardstand
Lag Storage Areas 3 & 4 and Shipping Depot	Operational	All waste removed; facilities remain	Remove facilities & foundations
Chemical Process Cell Waste Storage Area	Operational	Demolish facility & foundation	NA
Remote-Handled Waste Facility	Operational	Operational	Remove after remote-handled TRU waste has been shipped off-site
Lag Storage Building	Demolished to slab	Foundation remains	Remove foundation
Hazardous Waste Storage Lockers	Demolished	NA	NA

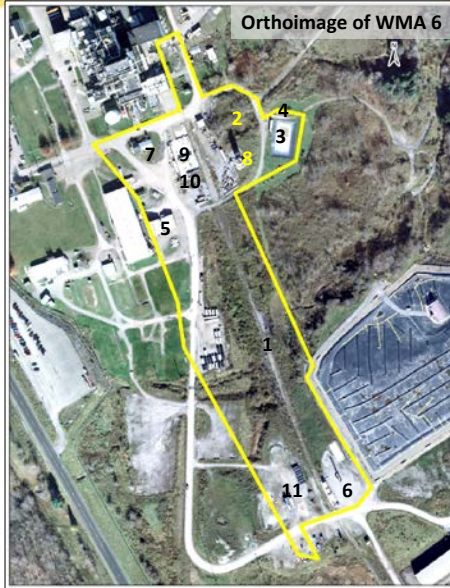
## WMA 6

1. Rail spur
2. Demineralizer sludge ponds (inactive)
3. Equalization basin
4. Equalization tank
5. Sewage Treatment Plant
6. Low-level waste rail packaging and staging area
7. Cooling tower
8. Two waste tank farm test towers
9. Old warehouse
10. Product Storage Area
11. HLW storage pad

Facility	January 2014 Status	Planned for End of Phase 1 Facility Disposition	Planned for End of Phase 1 Decommissioning
Rail Spur	Operable	Operational	Operational
Demineralizer Sludge Ponds	Inactive	No further action	Area restored
Equalization Basin	Operational	Remove facility & foundation	Area restored
Equalization Tank	Operational	Remove facility & foundation	Area restored
Sewage Treatment Plant	Operational	Remove facility & foundation	Area restored
Rail Packaging & Staging Area	Operational	Operational	Removed

Facility	January 2014 Status	Planned for End of Phase 1 Facility Disposition	Planned for End of Phase 1 Decommissioning
Cooling Tower	Demolished	Remove foundation	Area restored
Waste Tank Farm Test Towers	Demolished	Remove foundation	Area restored
Old Warehouse	Demolished	Area graded	Area restored
Product Storage Area	Demolished	Area graded	Area restored
HLW Storage Pad	Pad construction complete	HLW canisters stored in casks on the pad	HLW canisters stored in casks on the pad

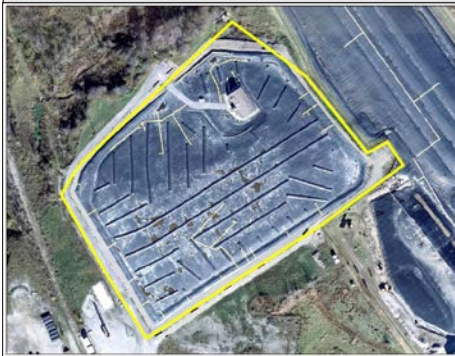
Orthoimage of WMA 7  
NRC-Licensed Disposal Area (NDA)

### NRC-Licensed Disposal Area Status

- A geomembrane cap and barrier wall were installed in 2008 to prevent water infiltration
- Liquid Pretreatment System is operable
- The NDA will remain in place during Phase 1 decommissioning

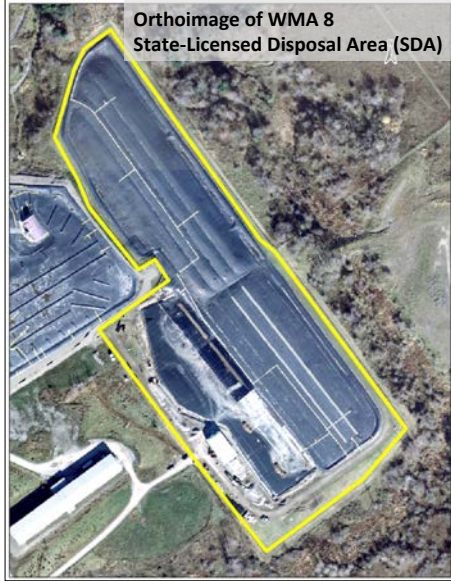
## WMA 8

### State-Licensed Disposal Area Status

- The geomembrane cap and barrier wall prevent water infiltration into the disposal area
- The leachate treatment facility was clean-closed and no longer stores mixed waste
- The SDA will remain in place during Phase 1 decommissioning

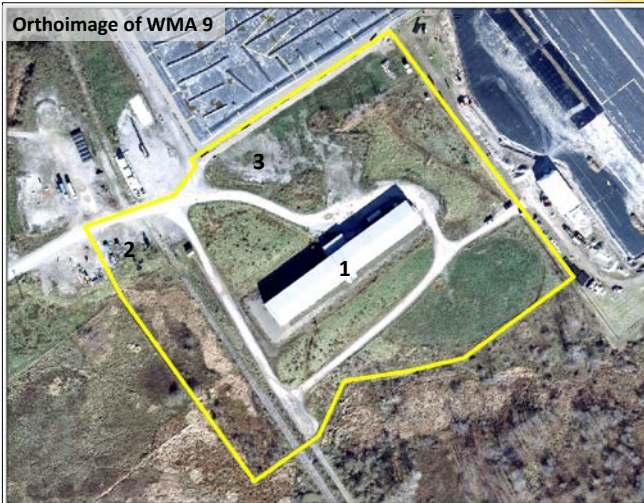
## WMA 9

1. Drum Cell
2. Subcontractor Maintenance Area
3. NDA Trench Container Area Pad

Facility	January 2014 Status	Planned for End of Phase 1 Facility Disposition	Planned for End of Phase 1 Decommissioning
Drum Cell	Operational; all waste has been removed	Facility & foundation removed; area restored	No further action
Subcontractor Maintenance Area	Operational	Operational	Removed
NDA Trench Container Area Pad	Operational	Operational	Removed

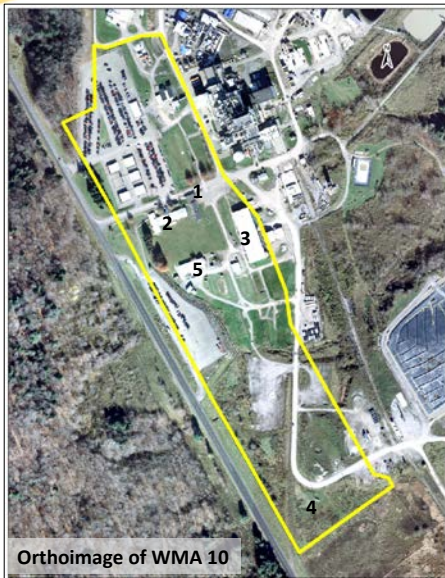
## WMA 10

1. Gatehouse
2. Administration Building
3. Warehouse
4. Meteorological Tower
5. Environmental Laboratory

Facility	January 2014 Status	Planned for End of Phase 1 Facility Disposition	Planned for End of Phase 1 Decommissioning
Gatehouse	Operational	Operational	Remains operational
Administration Building	Operational	Facility & foundation removed; area restored	No further action
Warehouse	Operational	Facility & foundation remain	Facility & foundation removed
Meteorological Tower	Operational	Operational	Remains operational
Environmental Laboratory	Demolished	Foundation removed; area restored	No further action

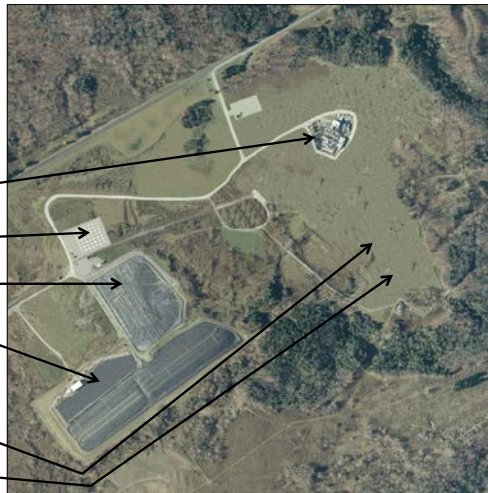
**At the end of Phase 1 decommissioning (Phase 1 facility disposition plus Phase 1 soil remediation) six facilities/ areas will remain:**

- Tank farm with the tank and vault drying system
- HLW storage casks
- NDA with cap and barrier wall
- SDA with cap and barrier wall
- Non-source area of groundwater plume
- Construction and Demolition Debris Landfill

- The Phase 2 decision includes WVDP and WYNSC facilities:
  - Waste Tank Farm
  - HLW Storage Casks
  - NRC-Licensed Disposal Area
  - State-Licensed Disposal Area
  - Construction and Demolition Debris Landfill
  - Contaminated media
    - Non-source area of the plume
    - Cesium prong
    - Streams
